**Re: Natural Resources Inventory
Former Cape Cod Sea Camps Properties
Bay Parcel - 3057 Main Street (Map 101, Lot 45)
Brewster, Massachusetts**

[LEC File #: ReedHLLC\22-321.01]

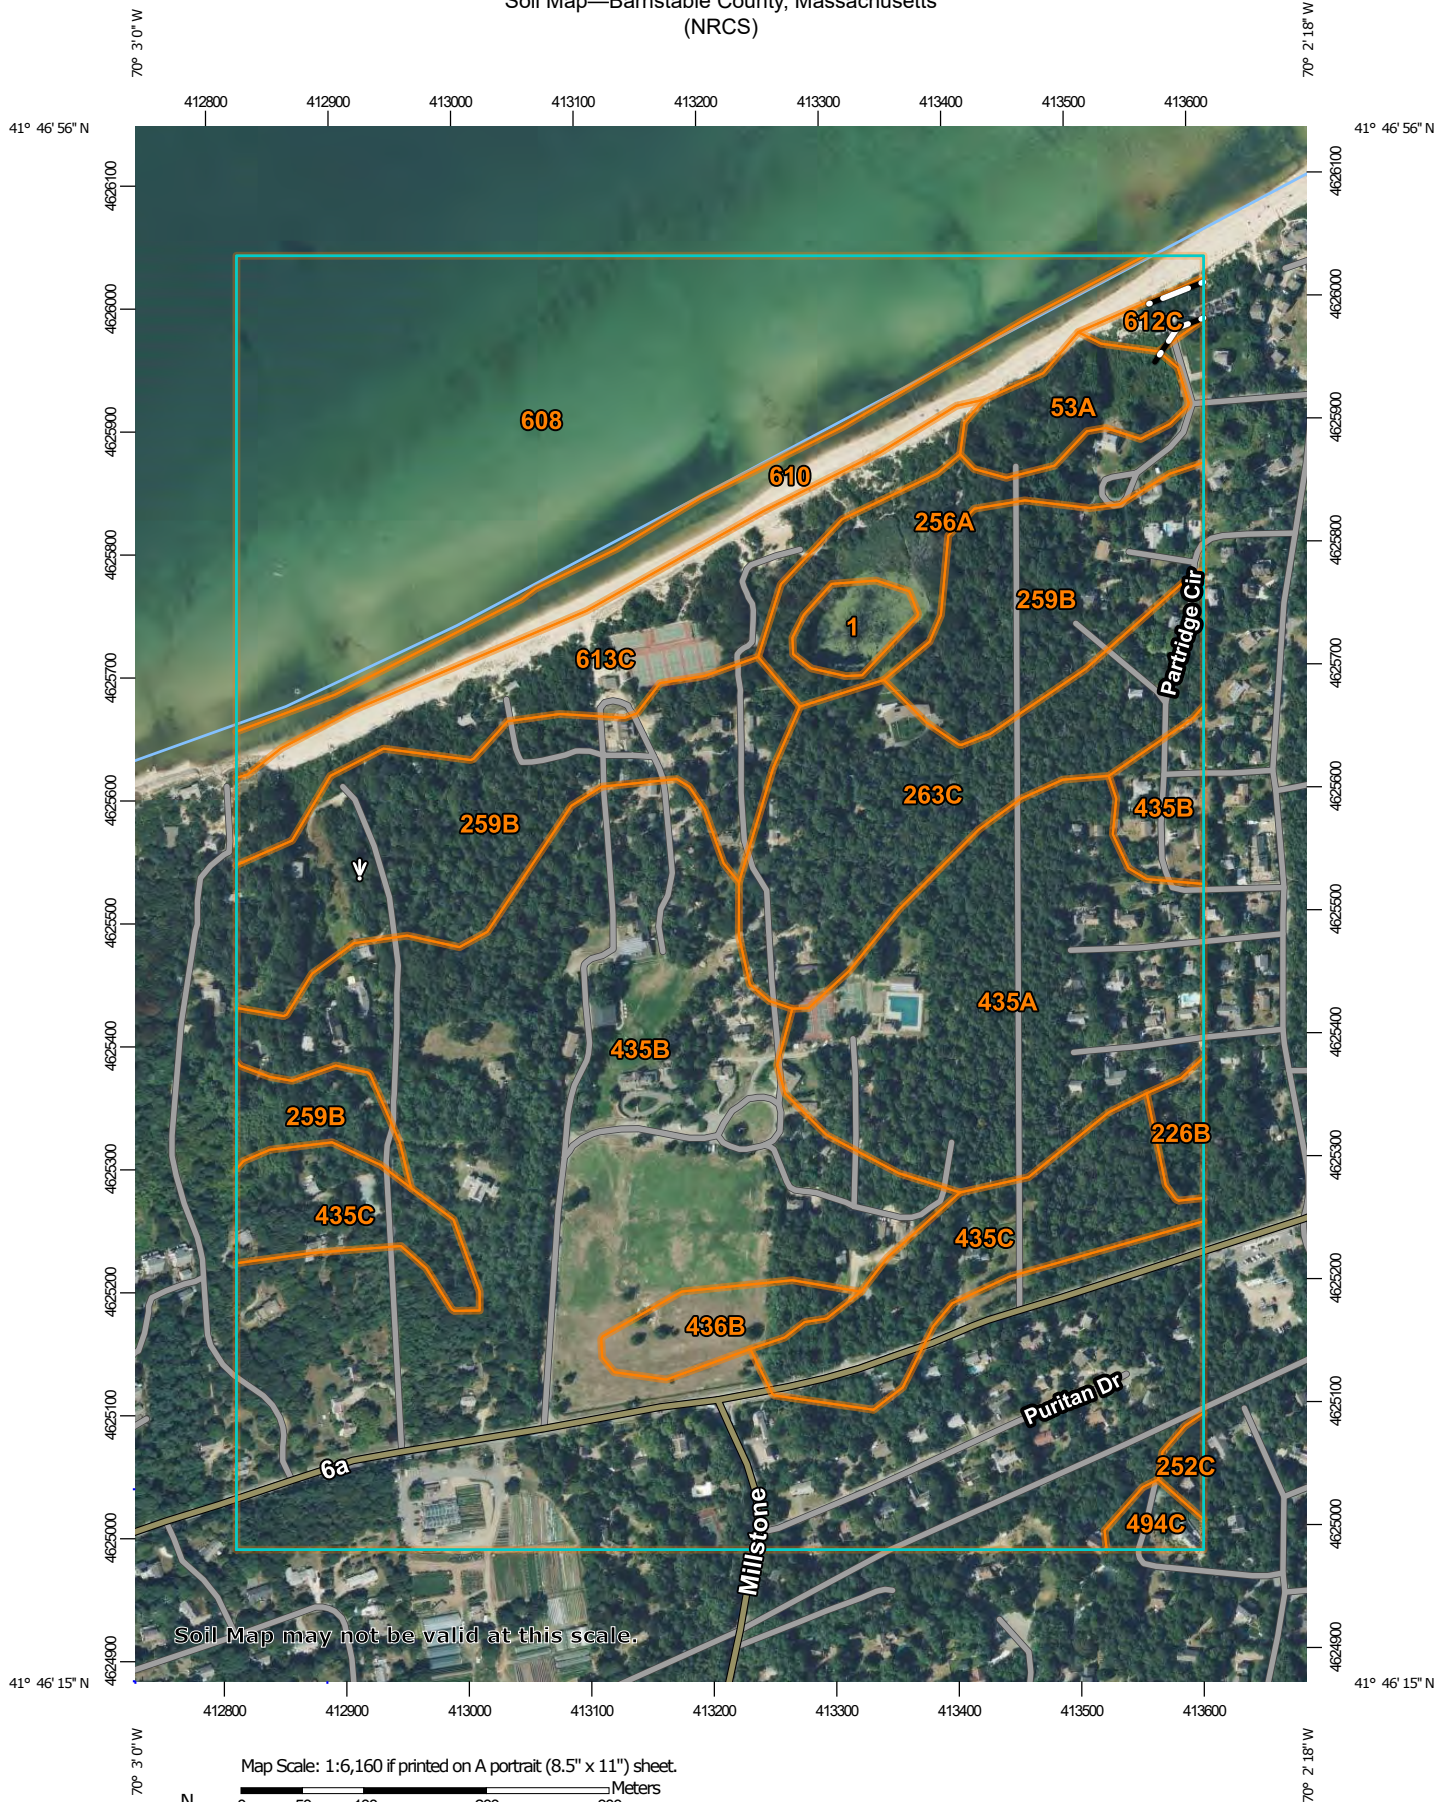
NRCS Web Soil Survey Map

According to the NRCS Web Soil Survey (**Attachment D**), the upland portions of the Property are mapped as Plymouth loamy coarse sands, Carver coarse sands, and Carver-Hinesburg loamy coarse sands. The Plymouth soil series are excessively drained sandy soils formed in glaciofluvial or deltaic deposits derived largely from siliceous rocks. The Carver soil series are excessively drained and formed

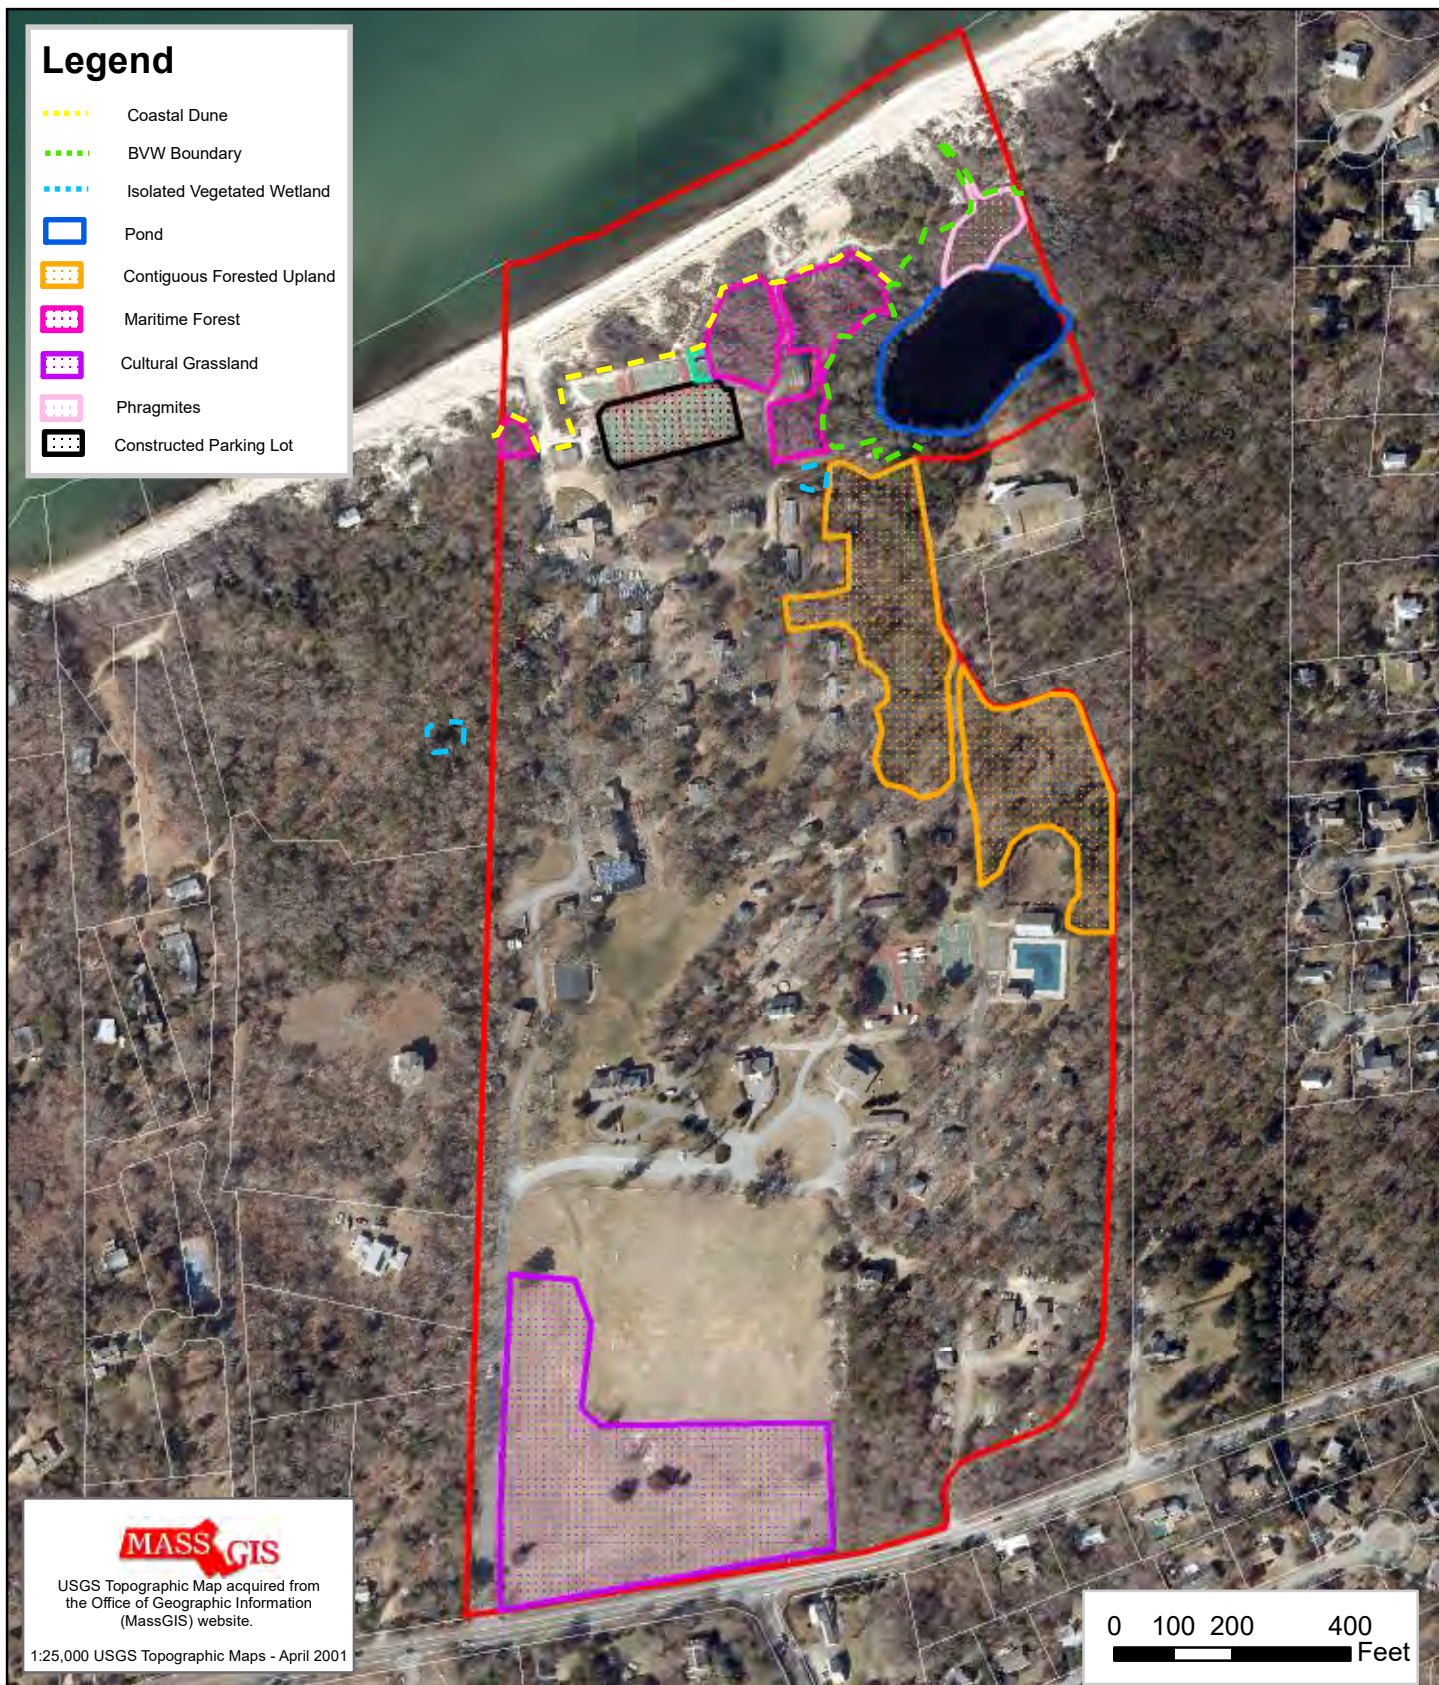
Habitat Cover Type Map

As mentioned above, the majority of the Property is occupied by developed conditions with fringing or patchy Forested Upland. Open Field conditions dominate the southerly portion of the Property. Bordering Vegetated Wetlands (BVW) extend off the Pond and a small Isolated Vegetated Wetland (IVW) is present immediately southwest of the Pond. The Coastal Dune and Coastal Beach within the northerly portion of the site is also described further below. Habitat cover types are depicted on the *Habitat Cover Type Map (Attachment E)*.

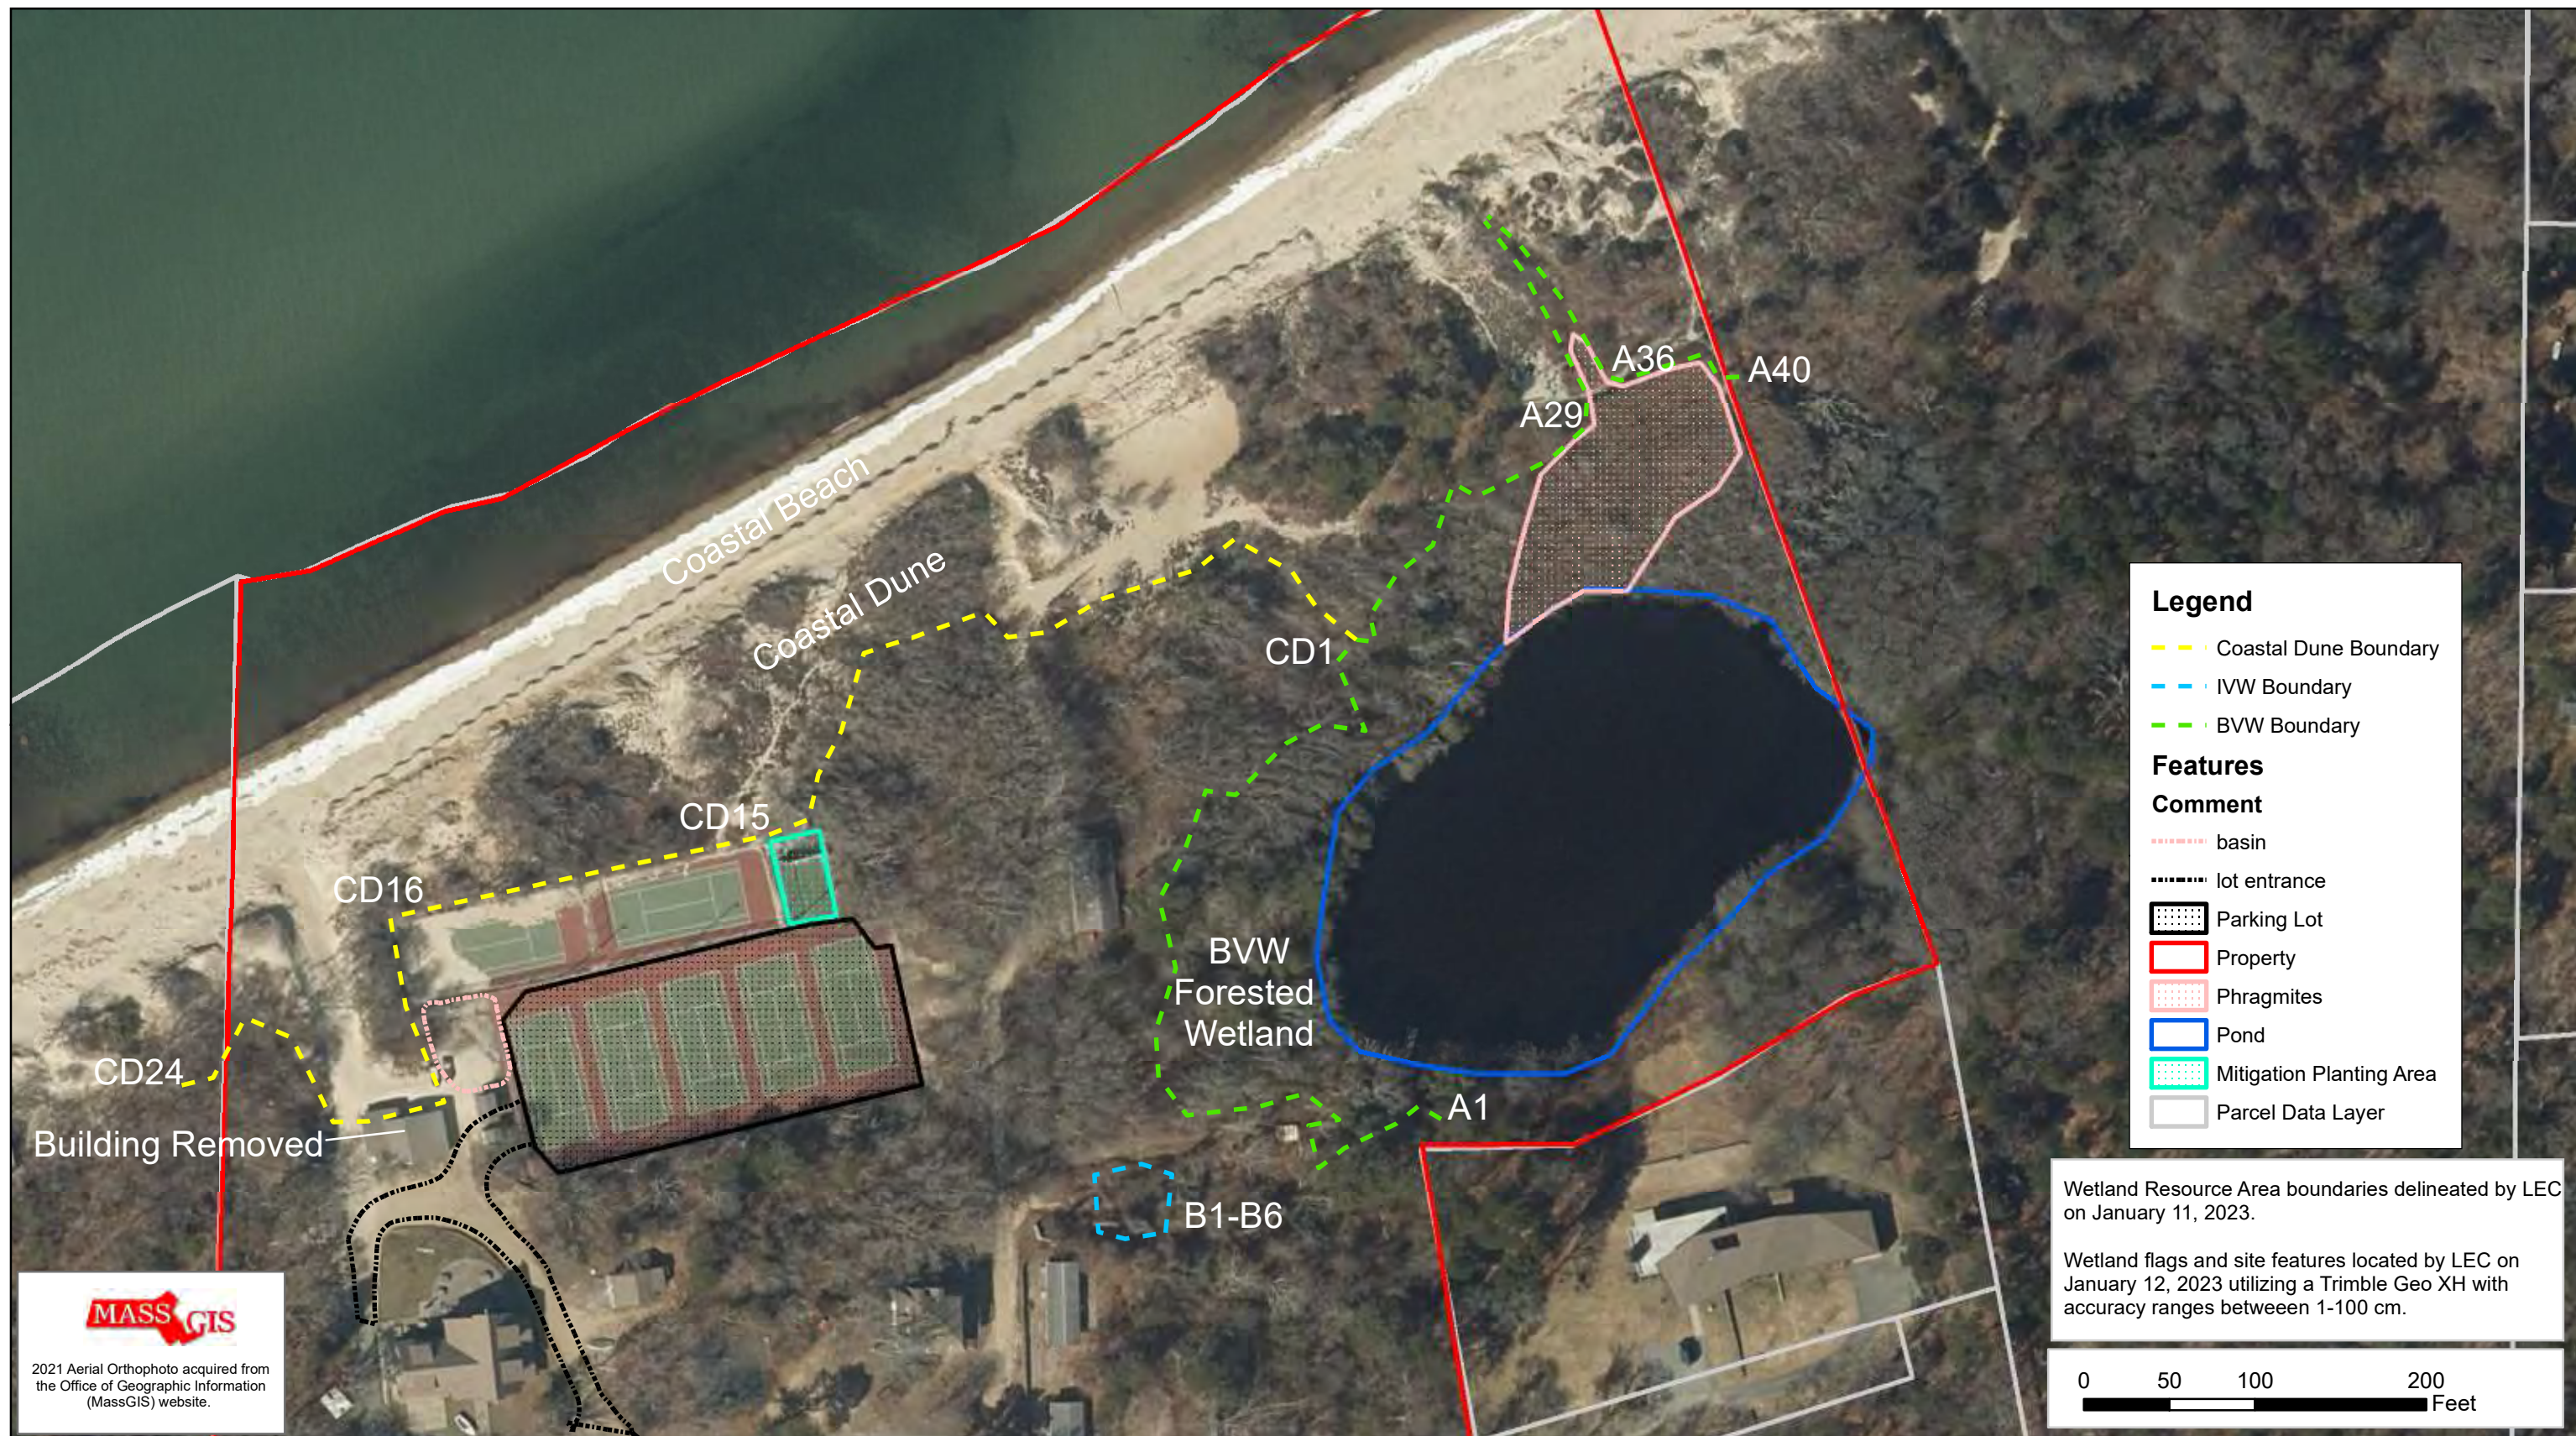
Wetlands Map

Wetland flags A1-A40 (BVW), and B1-B6 (IVW) are depicted on the *Wetland Map (Attachment F)*. The wetland flags were GPS-located by LEC utilizing a Trimble Handheld GEO XH-7000 Global Positioning System (GPS) unit with a post-processing accuracy ranging from 1-100 cm. The GPS data is intended for planning purposes only. Should a project proceed forward with permitting, a professional land surveyor or registered engineer will need to survey-locate the flags and plot them on a stamped survey plan.

The landward Coastal Dune boundary is defined by flags CD 1-24 and BVW flags A20-A44, where the Coastal Dune abuts the BVW north of the Pond as depicted the *Wetland Map (Attachment F)*.

It should be noted that a portion of the parking lot redevelopment occurred within 50 feet of the Coastal Dune and delineated by others. The Conservation Commission issued a Variance for the project, in part due to the project details, designed to avoid adverse impacts, the overriding public interest, and proposed mitigation measures, including erosion control measures, improved stormwater management, and native plantings, that contribute to the protection of the resource values (interests) identified in the *Bylaw*. It is LEC's understanding that the mitigation plantings have not yet been installed as part of the open Order of Conditions. The mitigation planting area is represented on the *Wetlands Map (Attachment F)*.

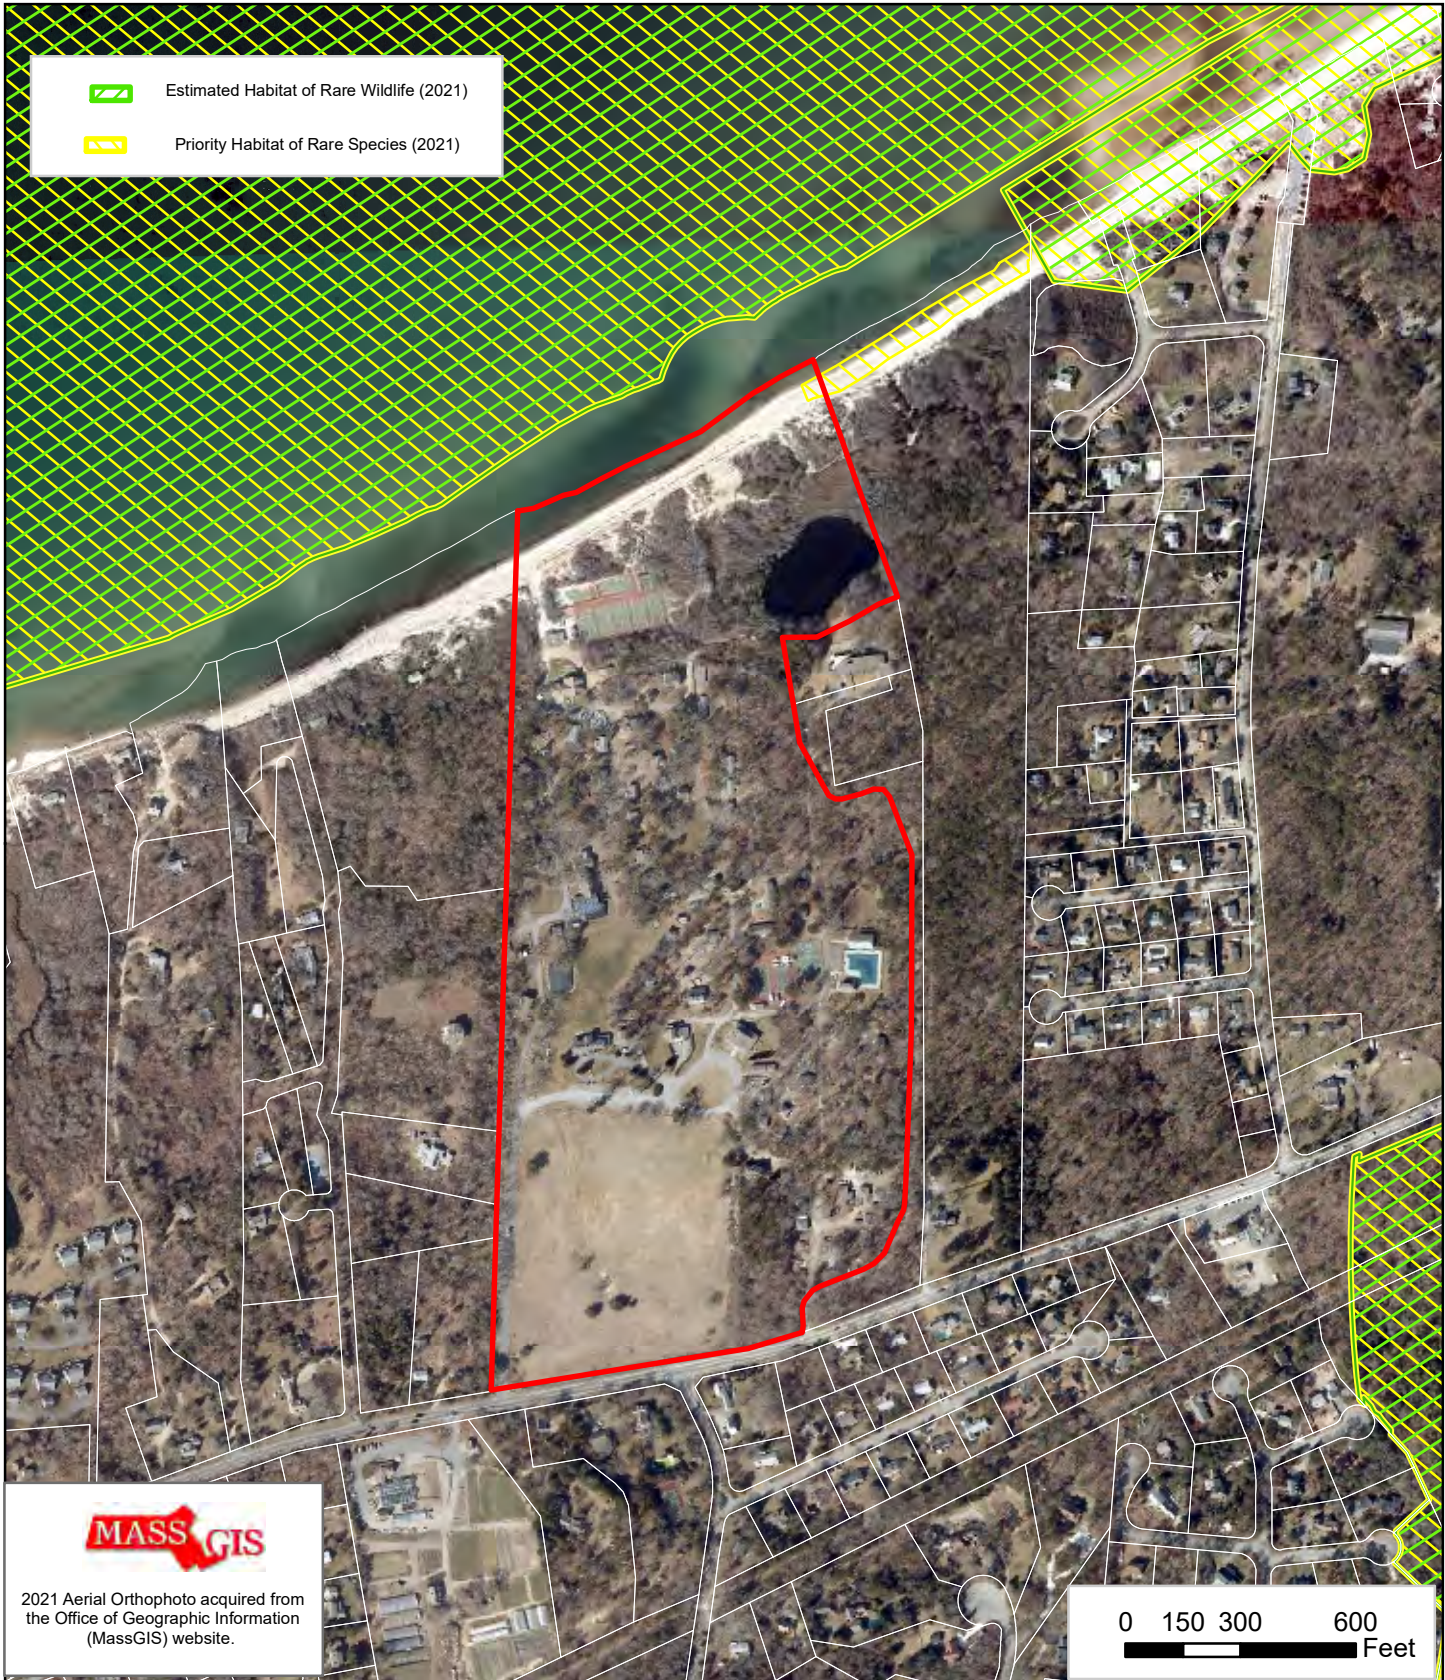
NHESP Map

According to the 15th Edition of the *Massachusetts Natural Heritage Atlas* (effective August 1, 2021) published by the Massachusetts Natural Heritage and Endangered Species Program (NHESP), upland portions of the Property are not located within a *Priority Habitat of Rare Species* and *Estimated Habitat of Rare Species (Attachment H)*. Priority Habitat 474 (PH 474) minimally extends onto the northeasterly corner of the Property and is confined to a narrow section of the Coastal Beach along the intertidal zone. PH 474 extends for approximately 700± linear feet, continuing off-site to the northeast,

and is presumably associated with foraging habitat for two rare birds: piping plover (*Charadrius melodus*) and/or common tern (*Sterna hirundo*). PH 892 occurs 660± linear feet northeast of the Property and includes Coastal Beach and Coastal Dune areas proximate to Linnell Landing Beach where shorebirds are known to nest.

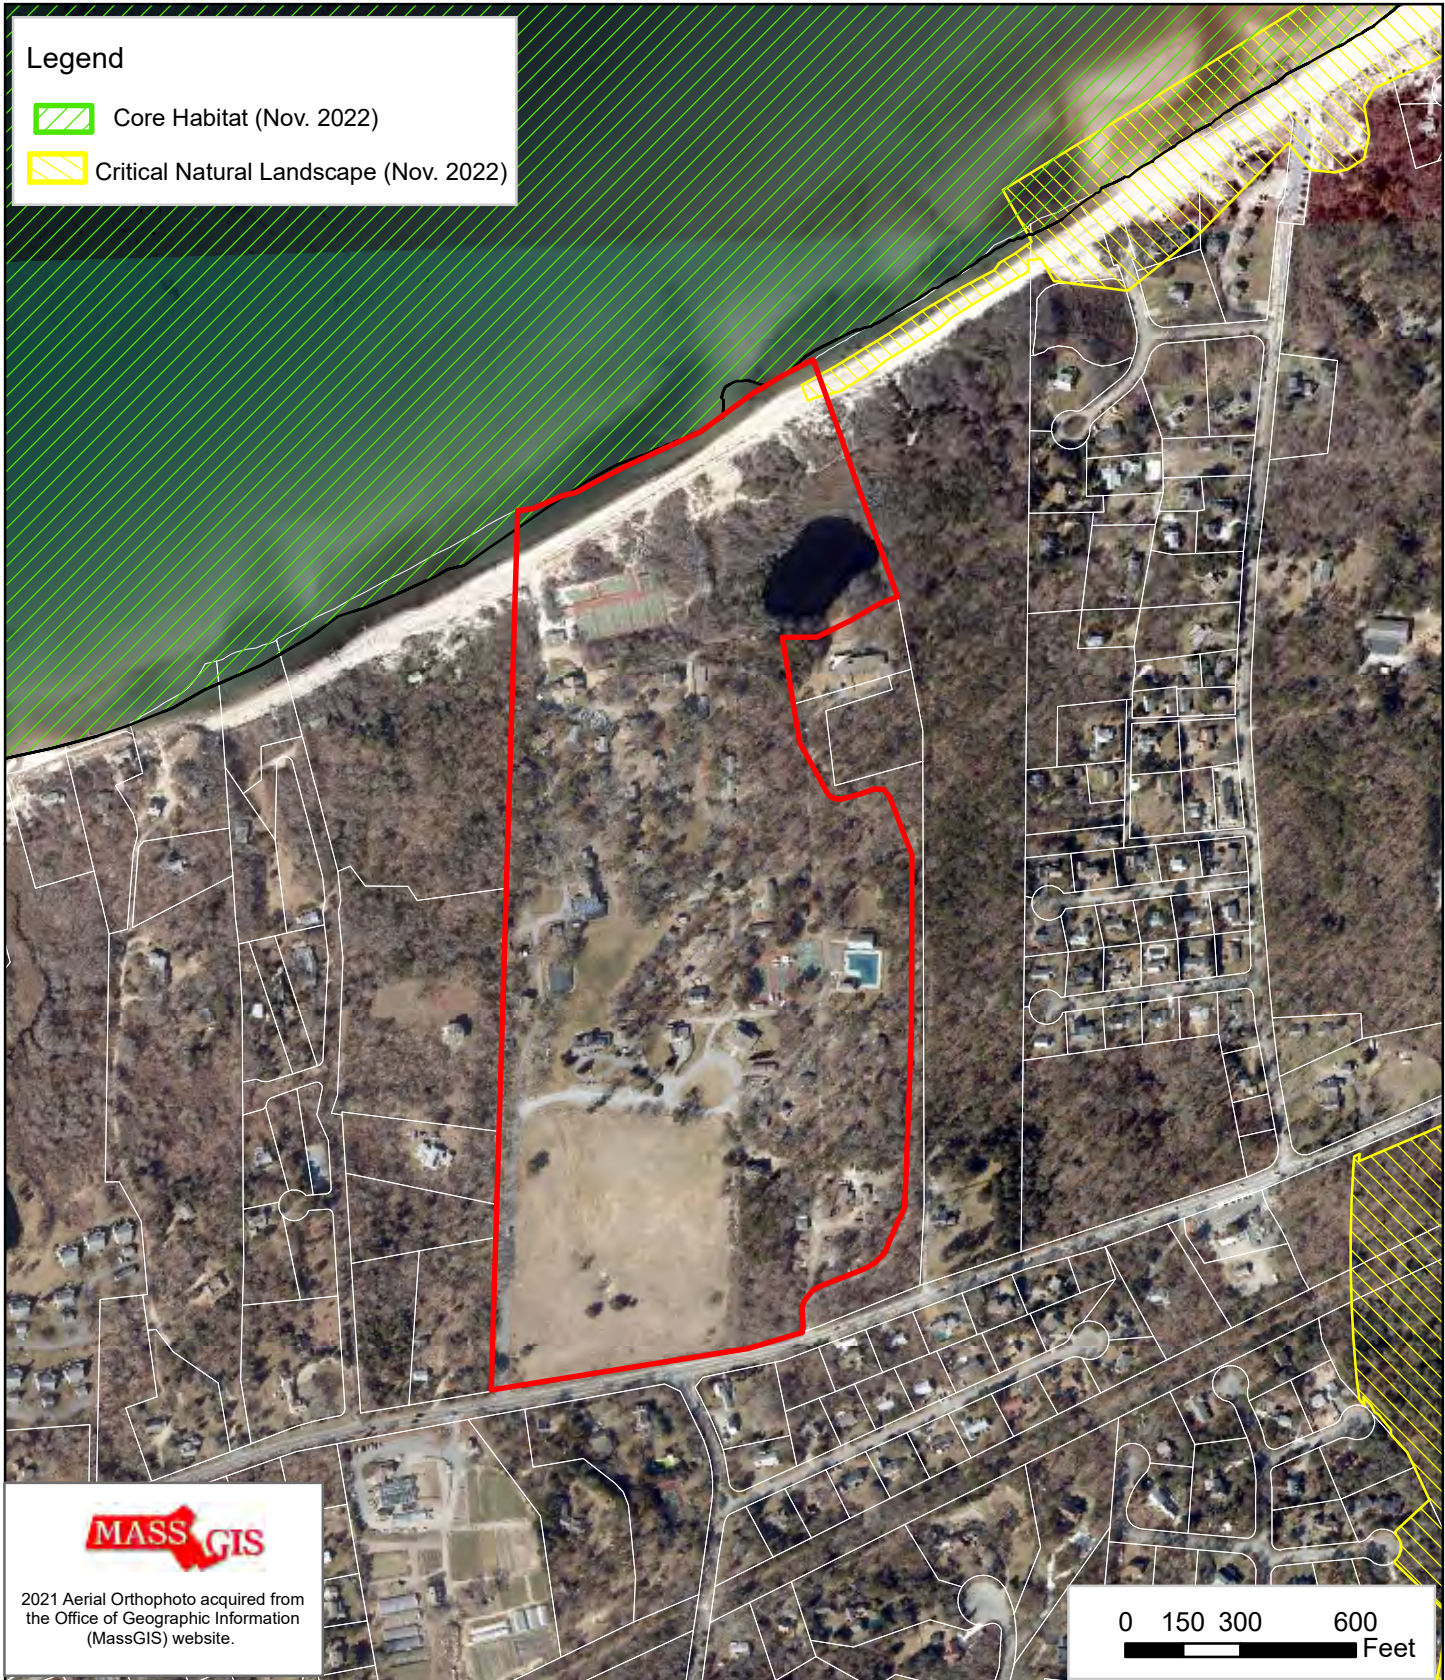
BioMap

According to *BioMap* MassGIS data layers, the Property is not located within a “Critical Natural Landscape.” Core Habitat minimally extends onto the northeasterly portion of the Coastal Beach, coincident with the NHESP rare species mapping (**Attachment I**).

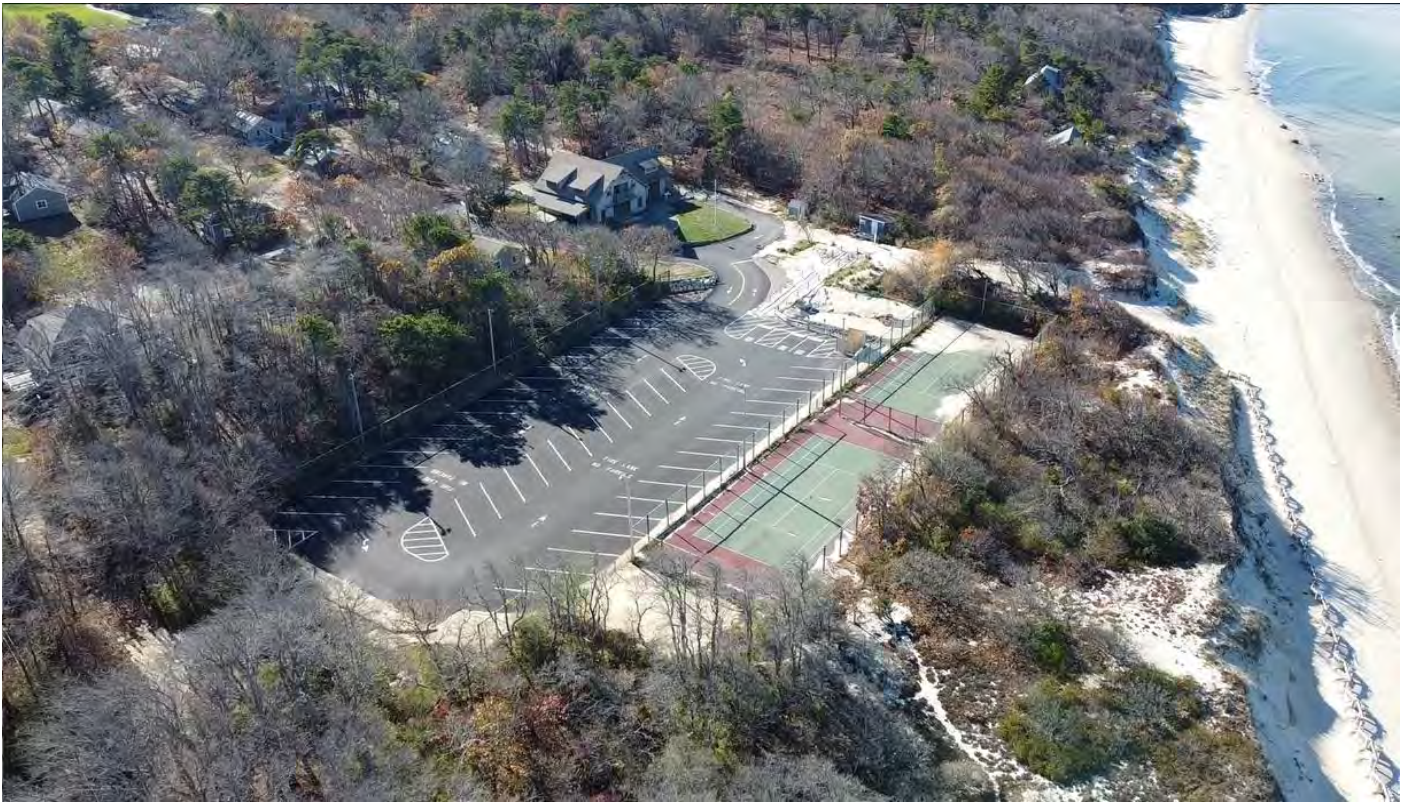
A paved parking lot for public beach access was recently constructed in 2022 within the northerly portion of the site, replacing five (5) tennis courts. Two tennis courts remain immediately north of the parking lot. Considering that the proposed redevelopment occurred within the 100-foot Buffer Zone to protectable Coastal Resource Areas, the project received an Order of Conditions (DEP File #SE9-1924) from the Brewster Conservation Commission on April 27, 2022, specifically approving the *milling, repairing, and installing overlay pavement for an existing area of asphalt pavement, adjusting and paving an existing gravel access roadway, constructing an access driveway from an existing roadway, installing two stormwater management systems, and managing an access path to the beach. The project includes areas on and within 50 and 100 feet of coastal wetlands.* The boundaries to Coastal Beach, Coastal Dune, and Land Subject to Coastal Storm Flowage were not confirmed under the Order. The public beach is now named First Light Beach.

Photo 3: Westerly view of recently constructed parking lot (11/22/22).

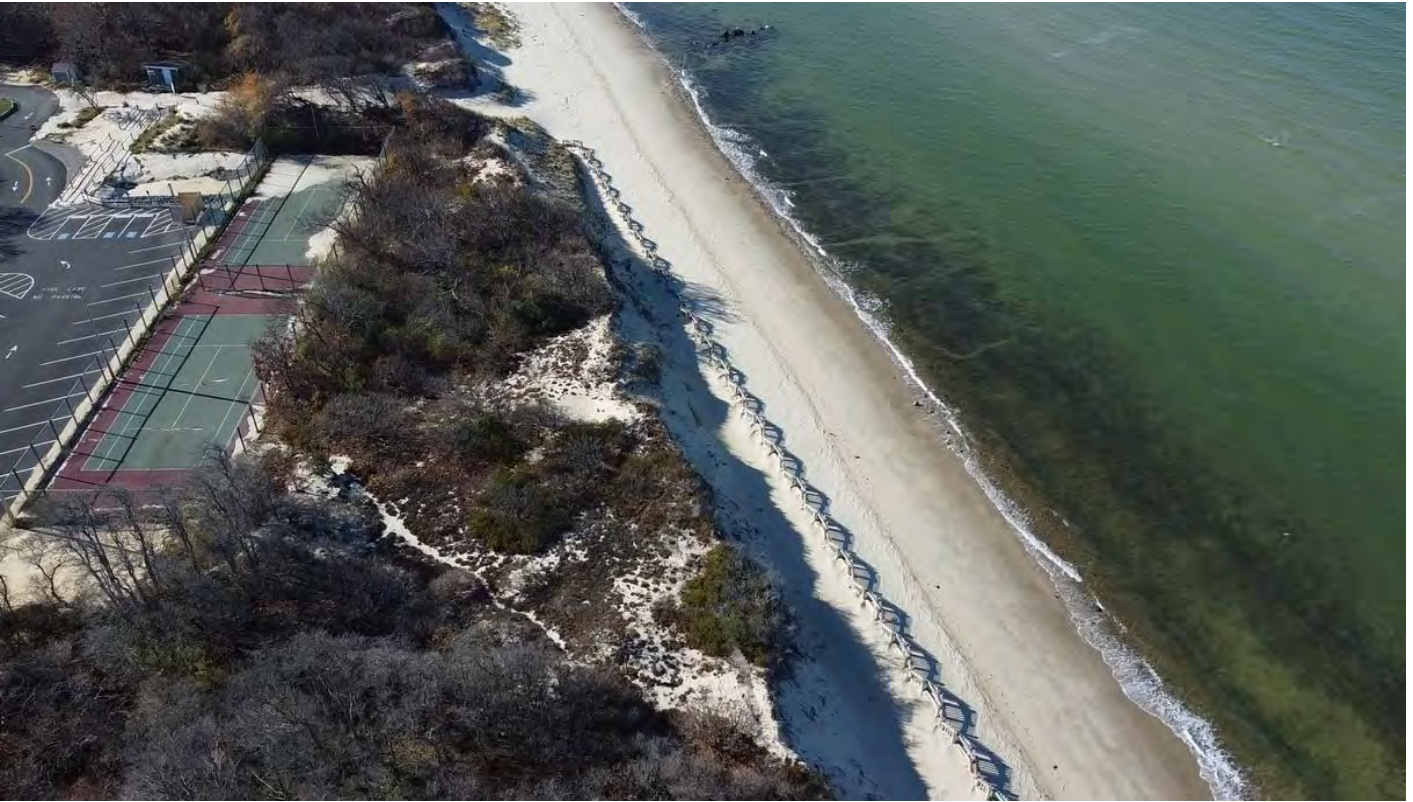
The seaward face of the Coastal Dune is composed of a mosaic of rolling vegetated surfaces, sloughing vegetation, and unvegetated, steep vertical cuts/embankments due to erosion from winds and storms.

Photo 4: Westerly view of Coastal Dune / shoreline (11/22/22).

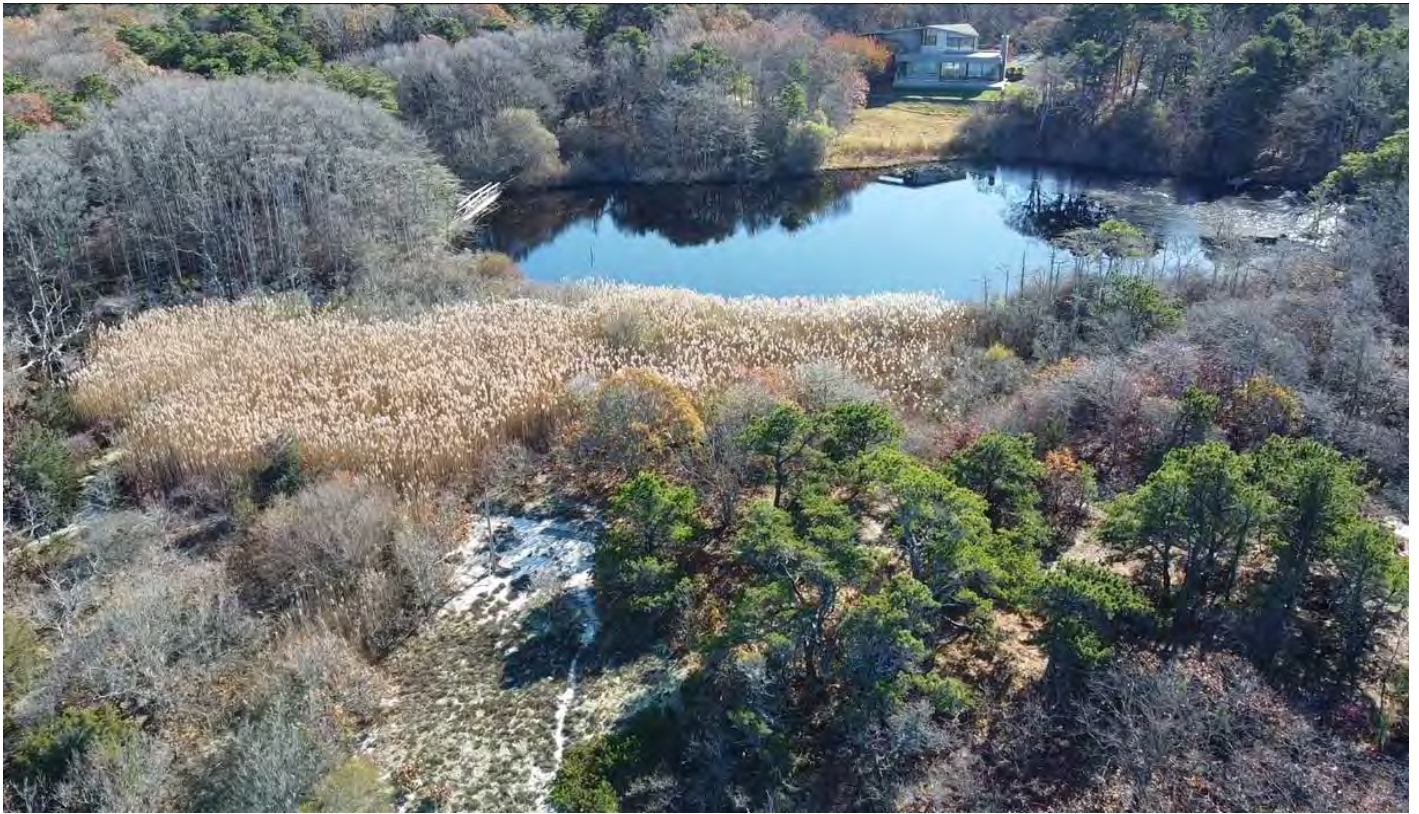
Photo 7: Southerly view of Pond and invasive *Phragmites* (11/22/22).

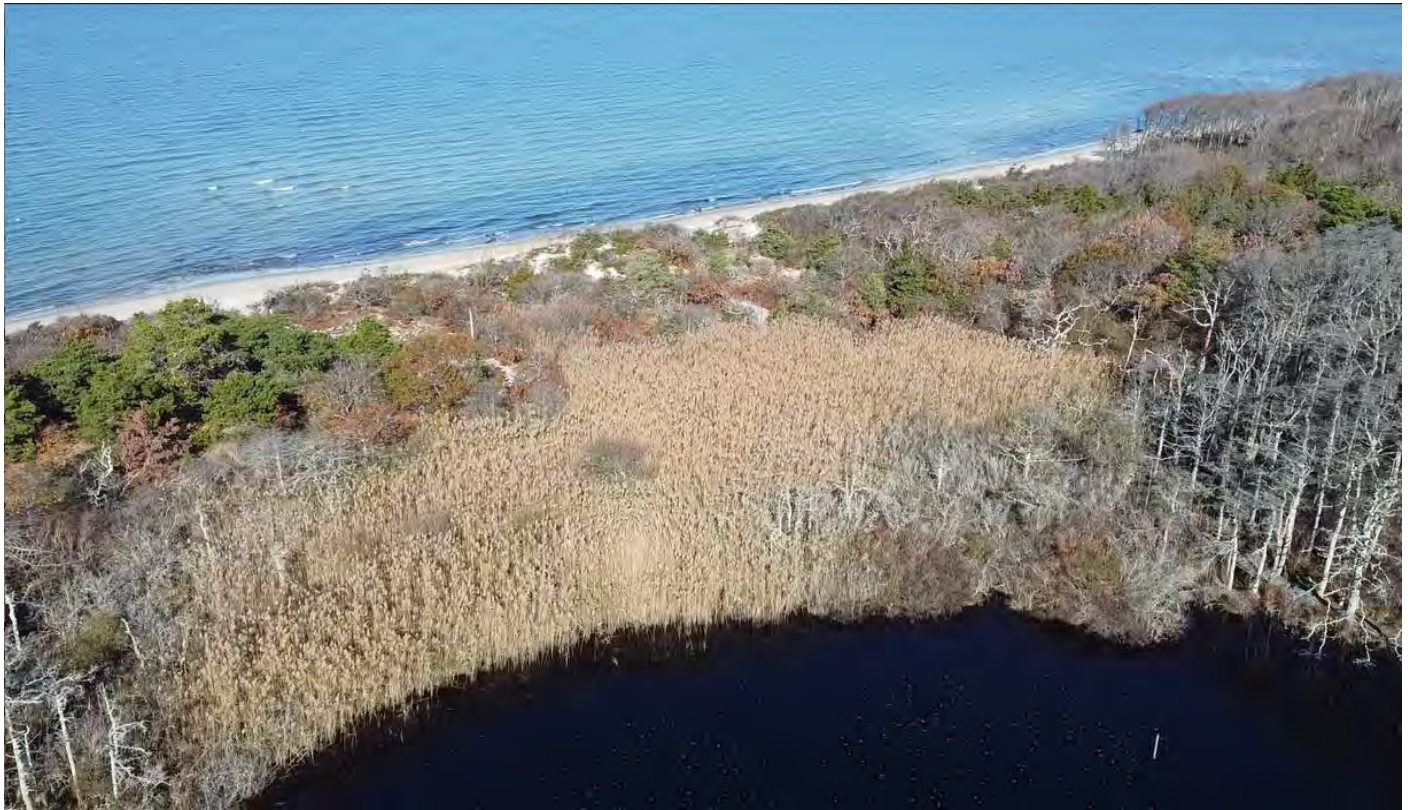
Photo 9: *Phragmites* stand present along northerly/northeasterly edge of Pond (11/22/22).

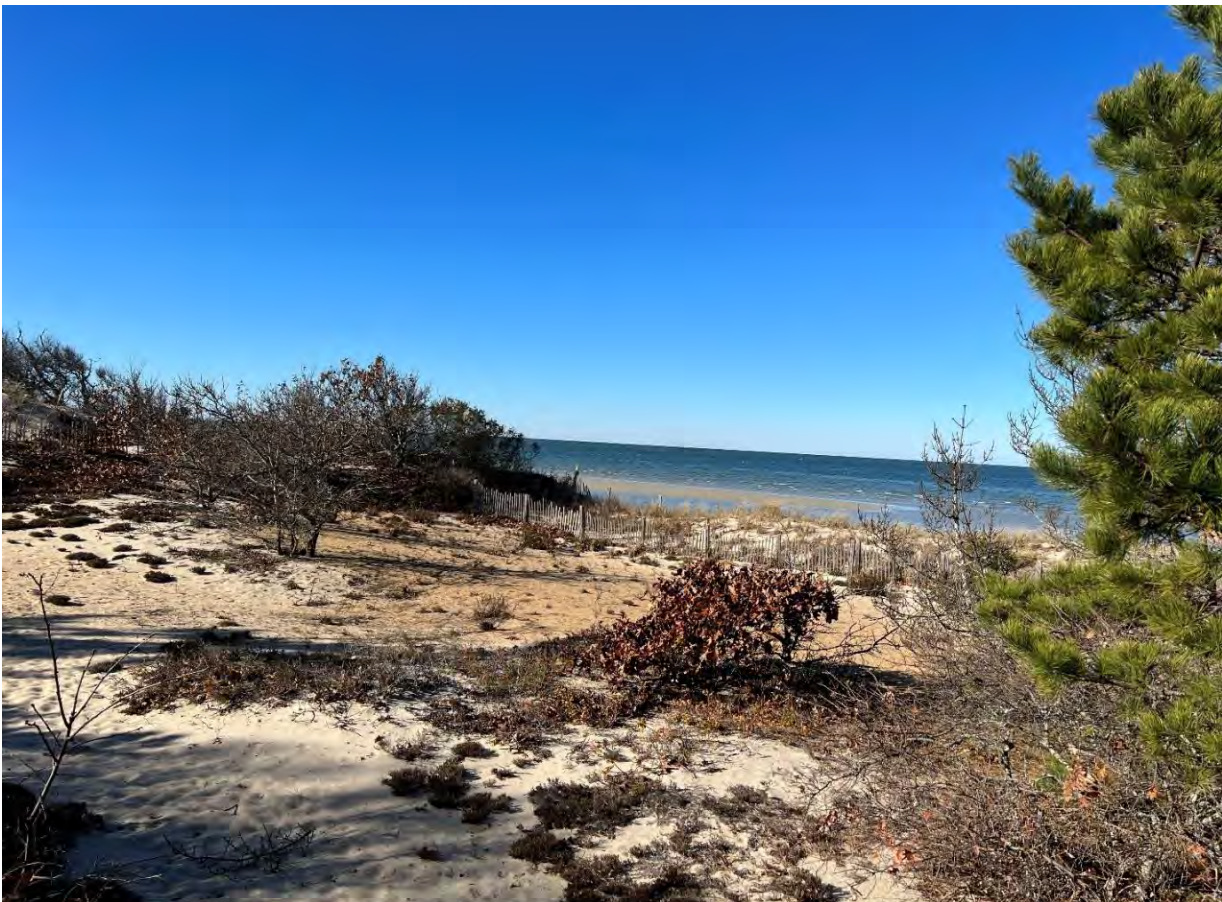
Photo 18: Former swimming pool footprint within Coastal Dune (11/21/22).

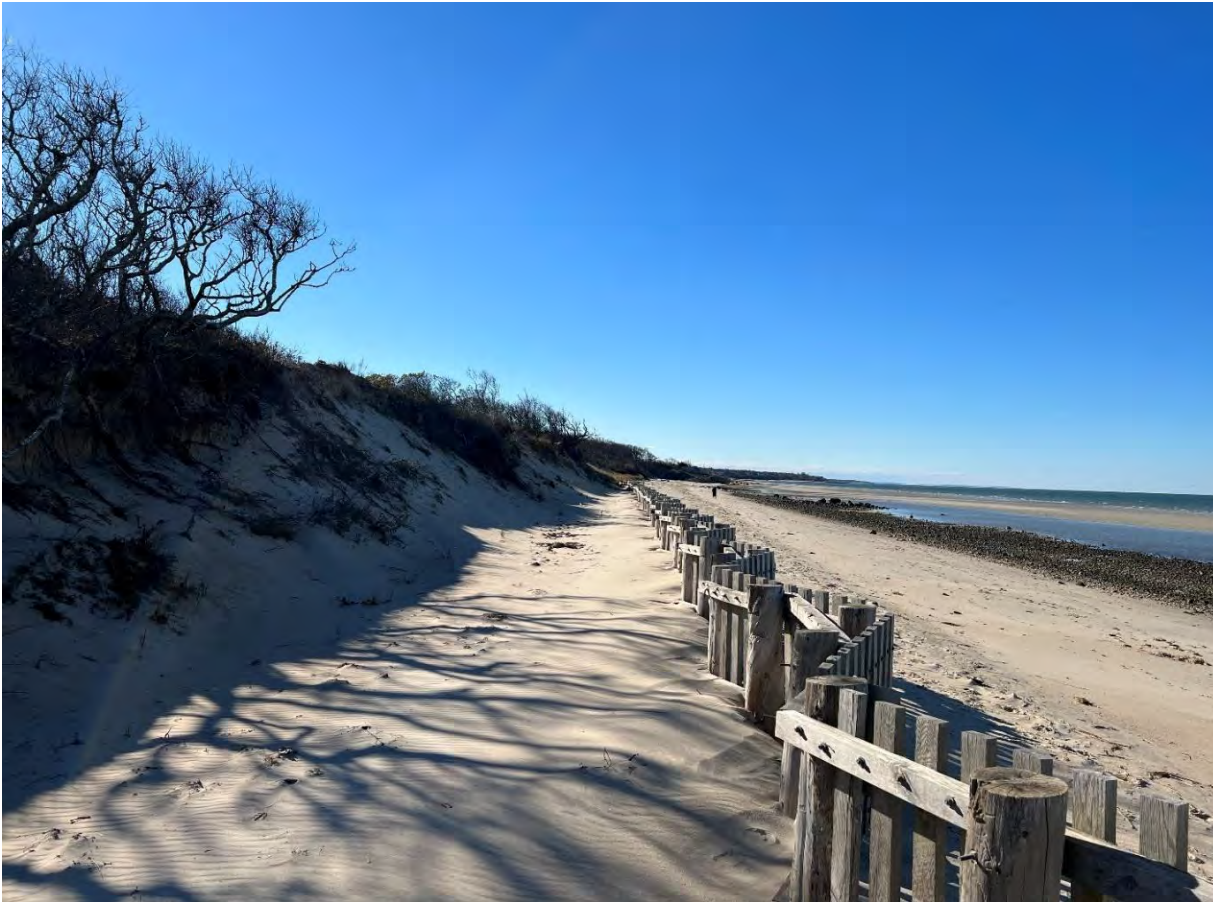
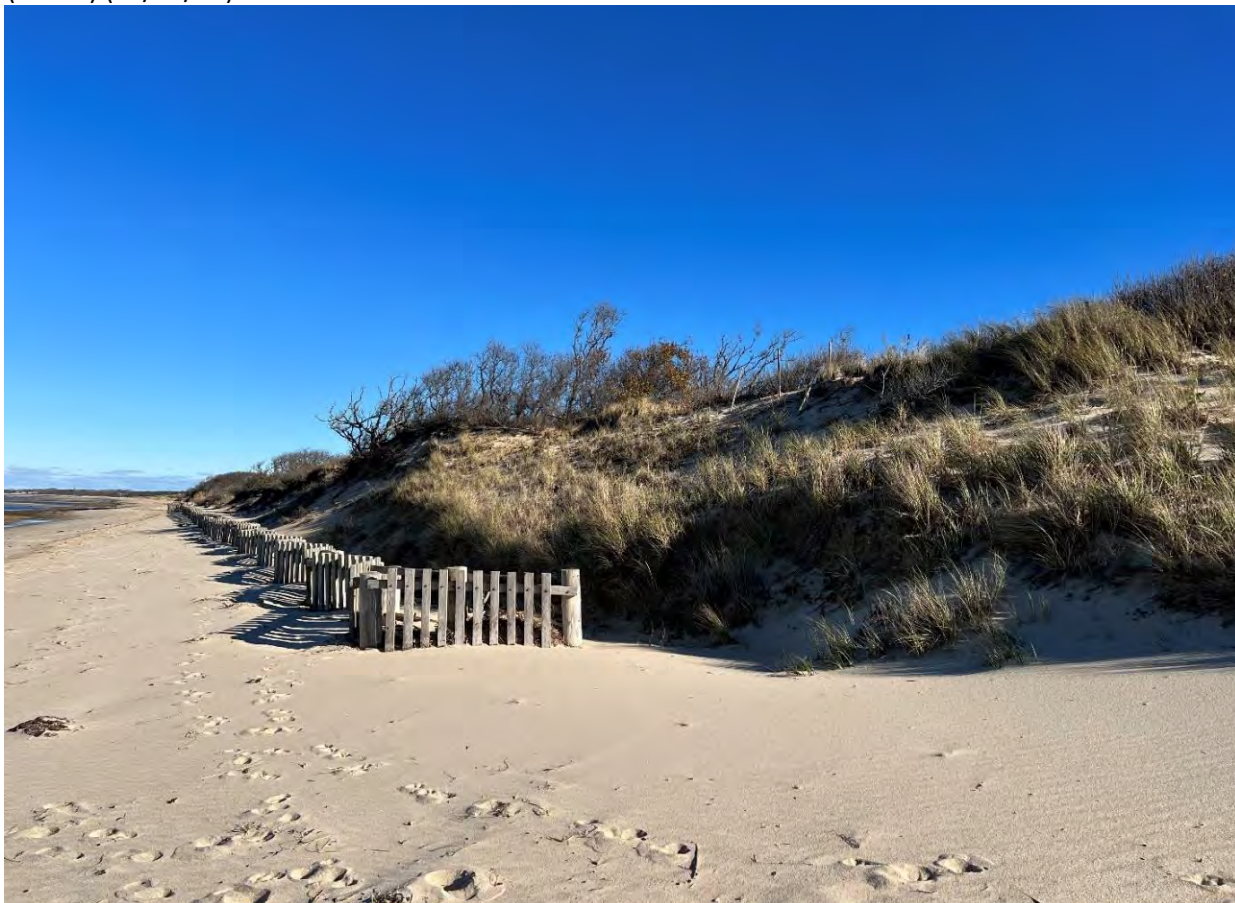
Photos 19 & 20: Coastal Dune/Beach interface and drift fencing, northerly (above) and southerly views (below) (11/21/22).
