**Re: Natural Resources Inventory
Former Cape Cod Sea Camps Properties
Bay Parcel - 3057 Main Street (Map 101, Lot 45)
Brewster, Massachusetts**

[LEC File #: ReedHLLC\22-321.01]

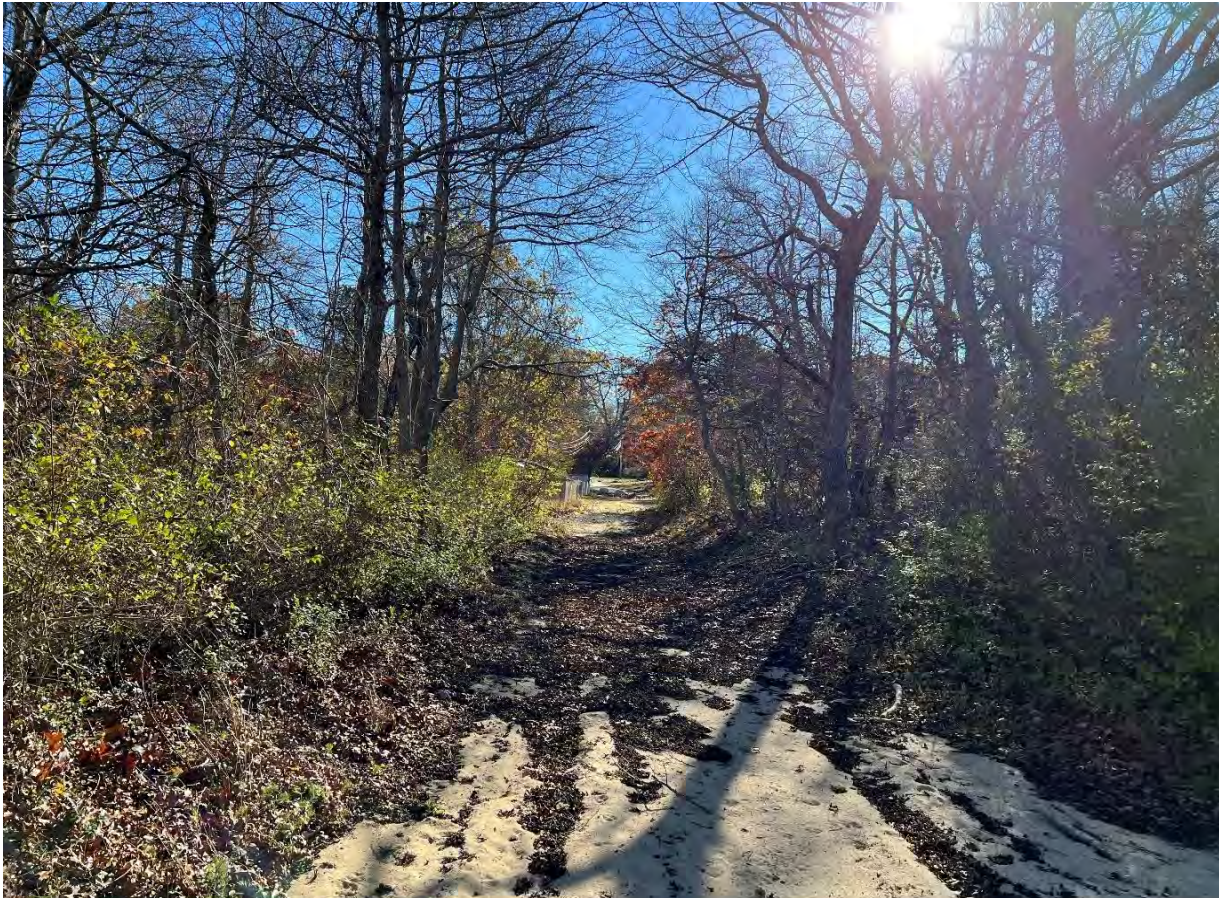
Maritime Forest habitat is present east/northeast of the recently constructed beach parking lot, abutting the Coastal Dune and BVW, in addition to immediately west of the First Light Beach access. The Maritime Forest contains tupelo (*Nyssa sylvatica*) stands amongst various oak, black cherry, and sassafras (*Sassafras albidum*) trees and saplings. The understory is intermittently occupied by bush honeysuckle, privet, and arrowwood. Pitch pine and eastern red cedar trees and/or saplings sporadically are present along the edge of adjacent developed conditions along with invasive species consisting of autumn olive (*Elaeagnus umbellata*), winged euonymus, and Asiatic bittersweet.

Photo 23: Maritime Forest within the northerly portion of the site (11/21/22).

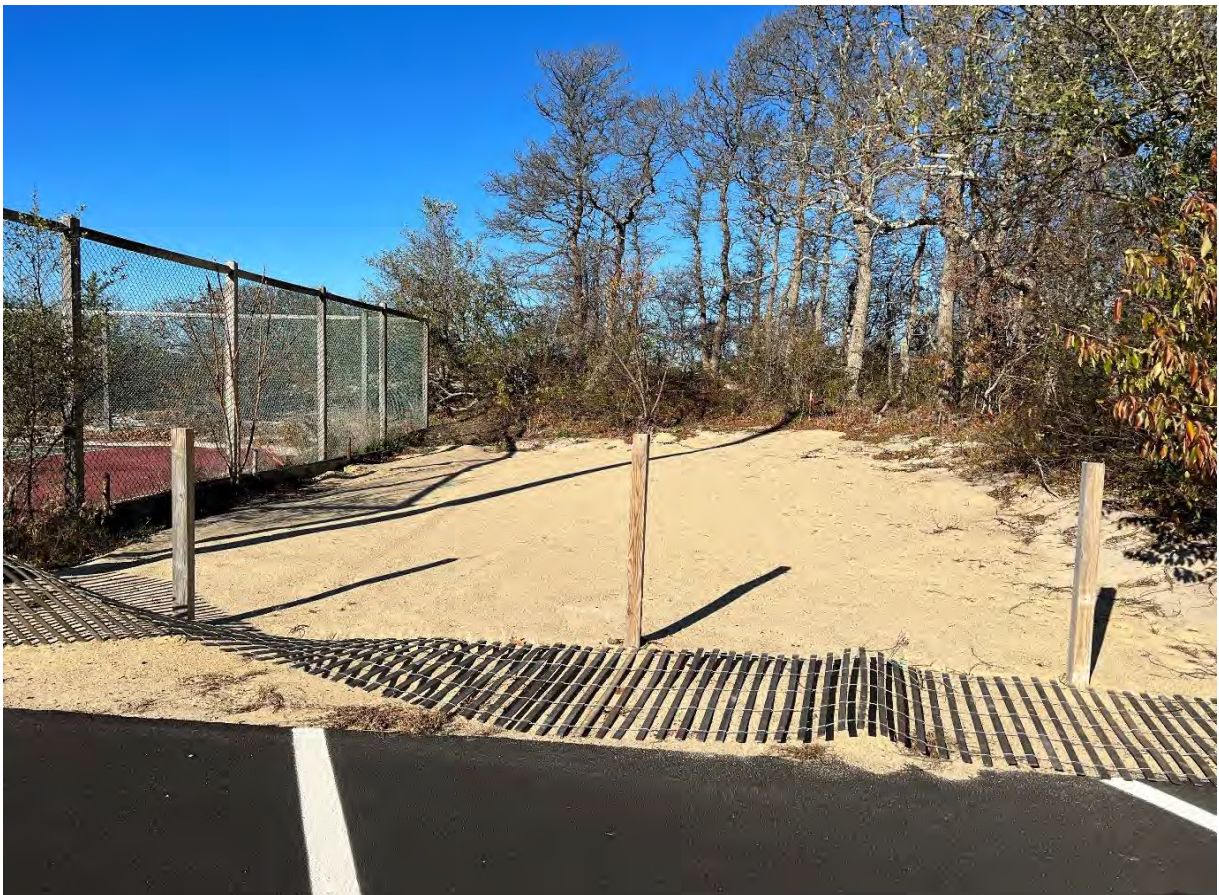
As evident by the accumulation of wind-blown sand within the northerly remaining tennis courts, continued landward migration of the Coastal Dune is expected in the short-term.

Photo 24: Mitigation Planting Area (to be planted) abutting parking lot, remaining tennis courts, Coastal Dune, and Maritime Forest (11/21/22).

- Remove the remaining northerly tennis courts and replace with natural, enhanced dune with vegetation to increase coastal resiliency and allow for the existing dune sand to migrate naturally.

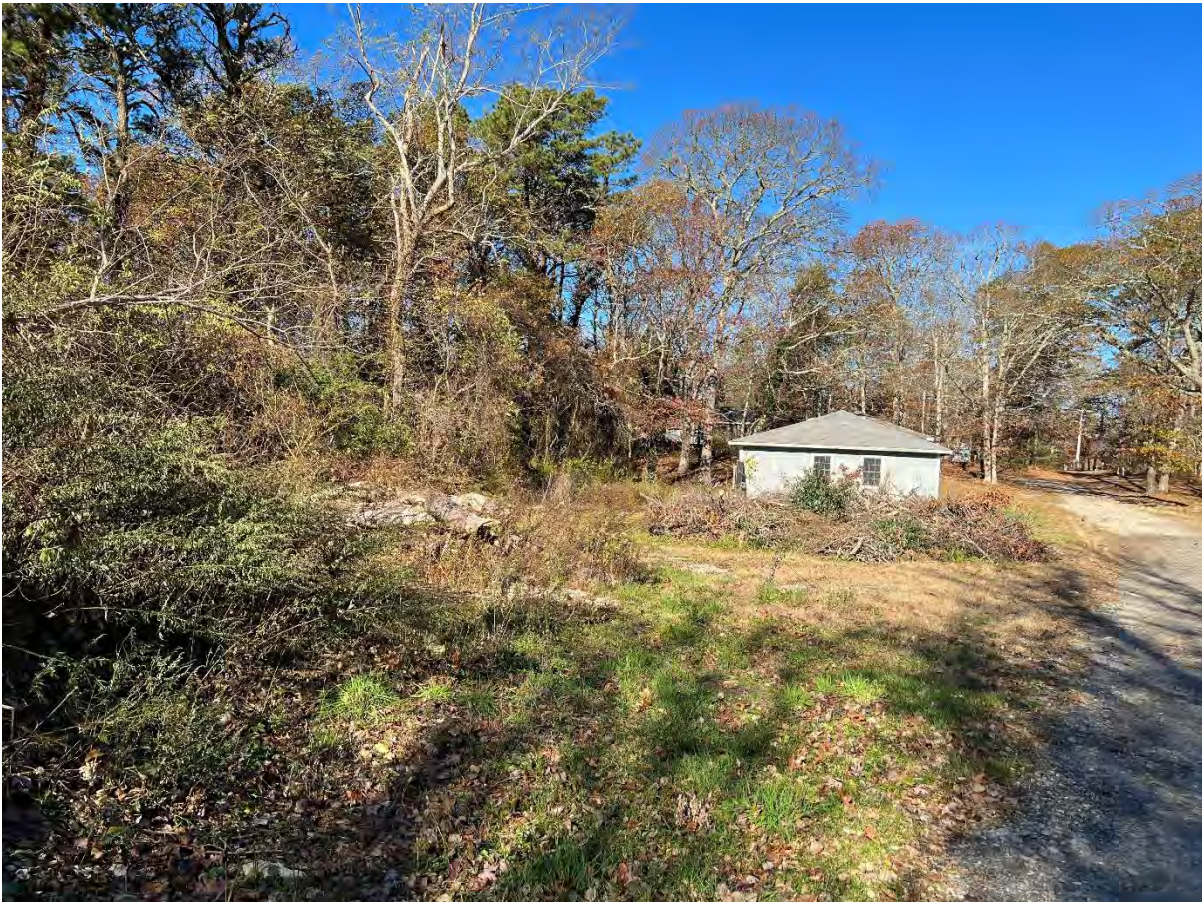
Invasive vegetation, listed as “Invasive” plants by the Massachusetts Invasive Species Plant Advisory Group (MIPAG), across the Property is more common along the edges of developed conditions, most notably abutting areas where vegetative debris has been stored or stockpiled. Small concentrations of invasive weeping lovegrass (*Eragrostis curvula*) and cypress spurge (*Euphorbia cyparissias*) (likely-invasive) were also observed proximate to Building #40 within the northeasterly portion of the Property. Additional herbaceous invasive species (e.g., garlic mustard) may also be present on-site; however, were not detectable at the time of the site evaluations due to the seasonality of their vegetative stages.

Photo 29: Fringing Forested Upland with significant invasive species within the southeasterly portion of the site (11/21/22).

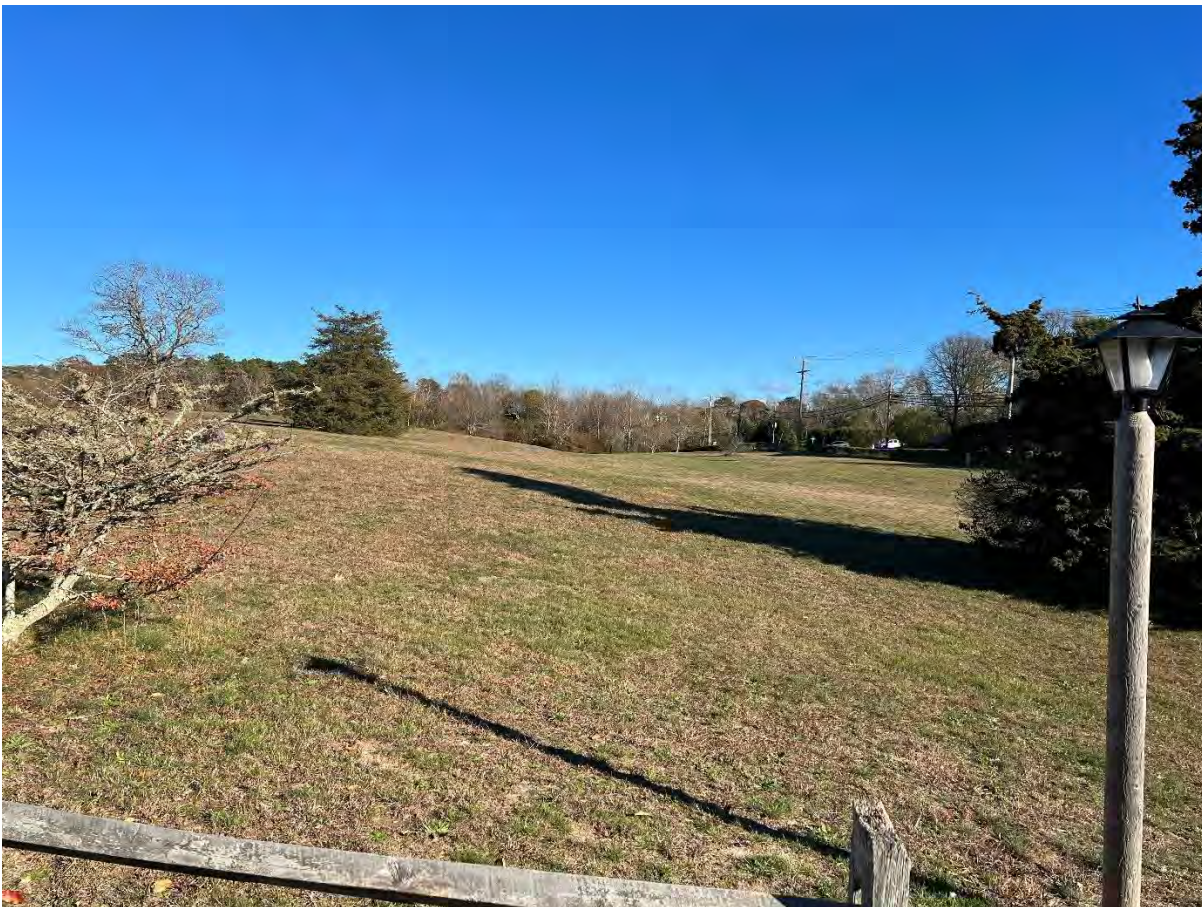
Approximately half of the 8± acre open field within the southwesterly portion of the site, abutting Main Street, is comprised of playing fields (baseball, football, and soccer). Surrounding field conditions resemble a Cultural Grassland; however, native grasses may be dominant. The entirety of the Open Field is actively mowed and the shorn grasses were not identifiable at the time of the site evaluations. Scattered trees, primarily eastern red cedar (*Juniperus virginiana*), and shrubs occur intermittently.

Photo 30: Cultural Grassland within southerly portion of site adjacent to Main St/Route 6 (11/21/22).
