Town of Brewster Sea Camps Pond Parcel Discovery Analysis

March 29, 2023

REED HILDERBRAND

Building Analysis

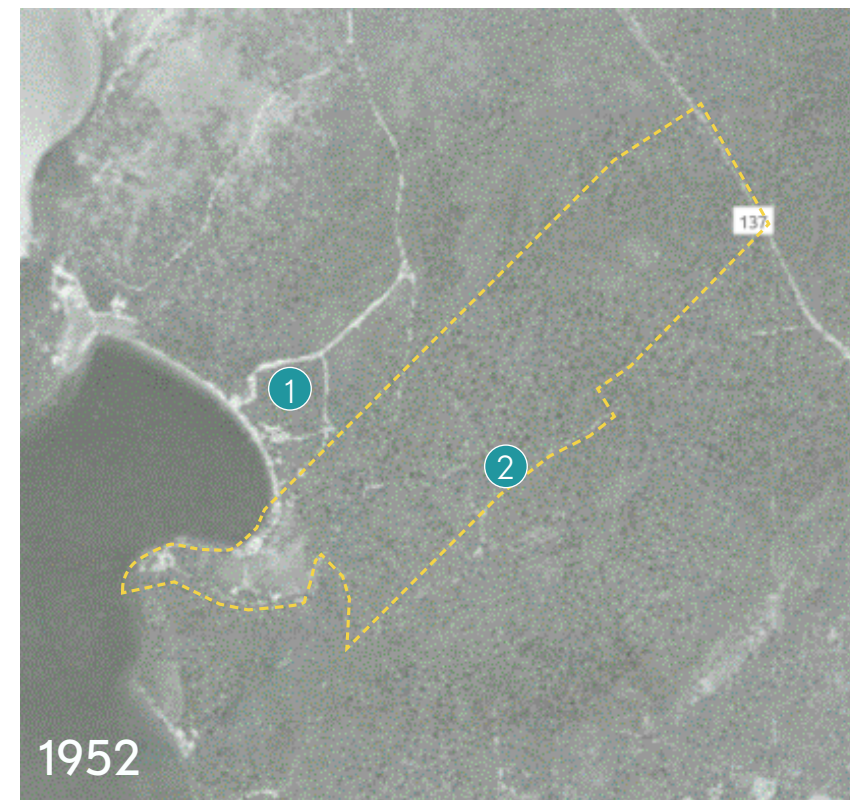
- 1 Roadways are added northwest of the parcel off of W.H. Besse Cartway.
- 2 The drive along the central-southern edge of the parcel has been reforested.

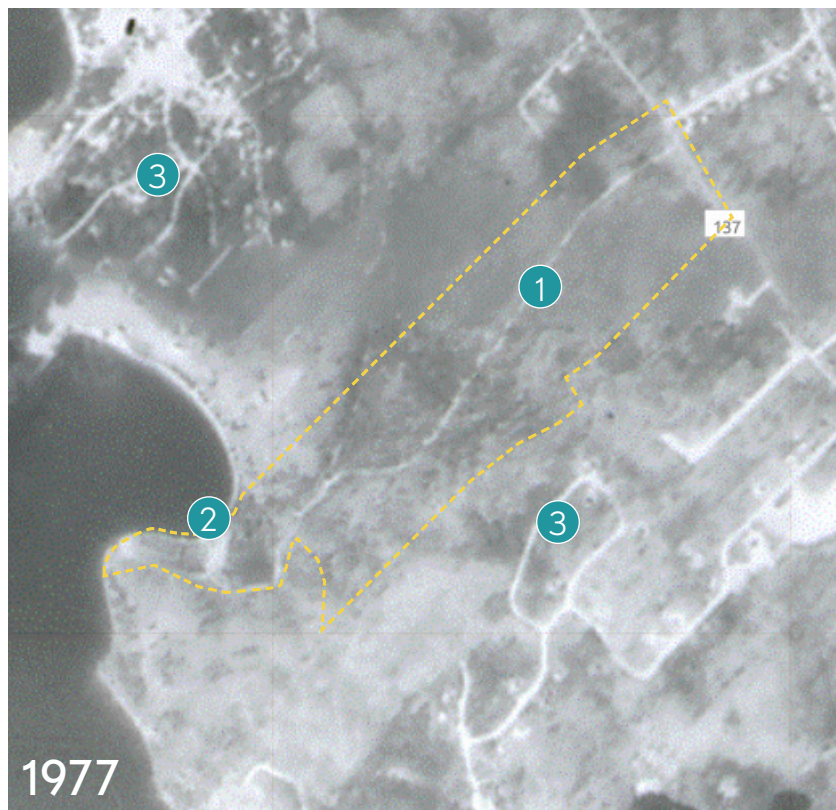
- 1 The access drive off of Route 137 is added for use by the Sea Camps.
- 2 Vegetation around the pond beach area is removed, creating a larger clearing. Small cabins and boat storage are built by the pond clearings.
- 3 Roadways to neighboring residential areas are developed.

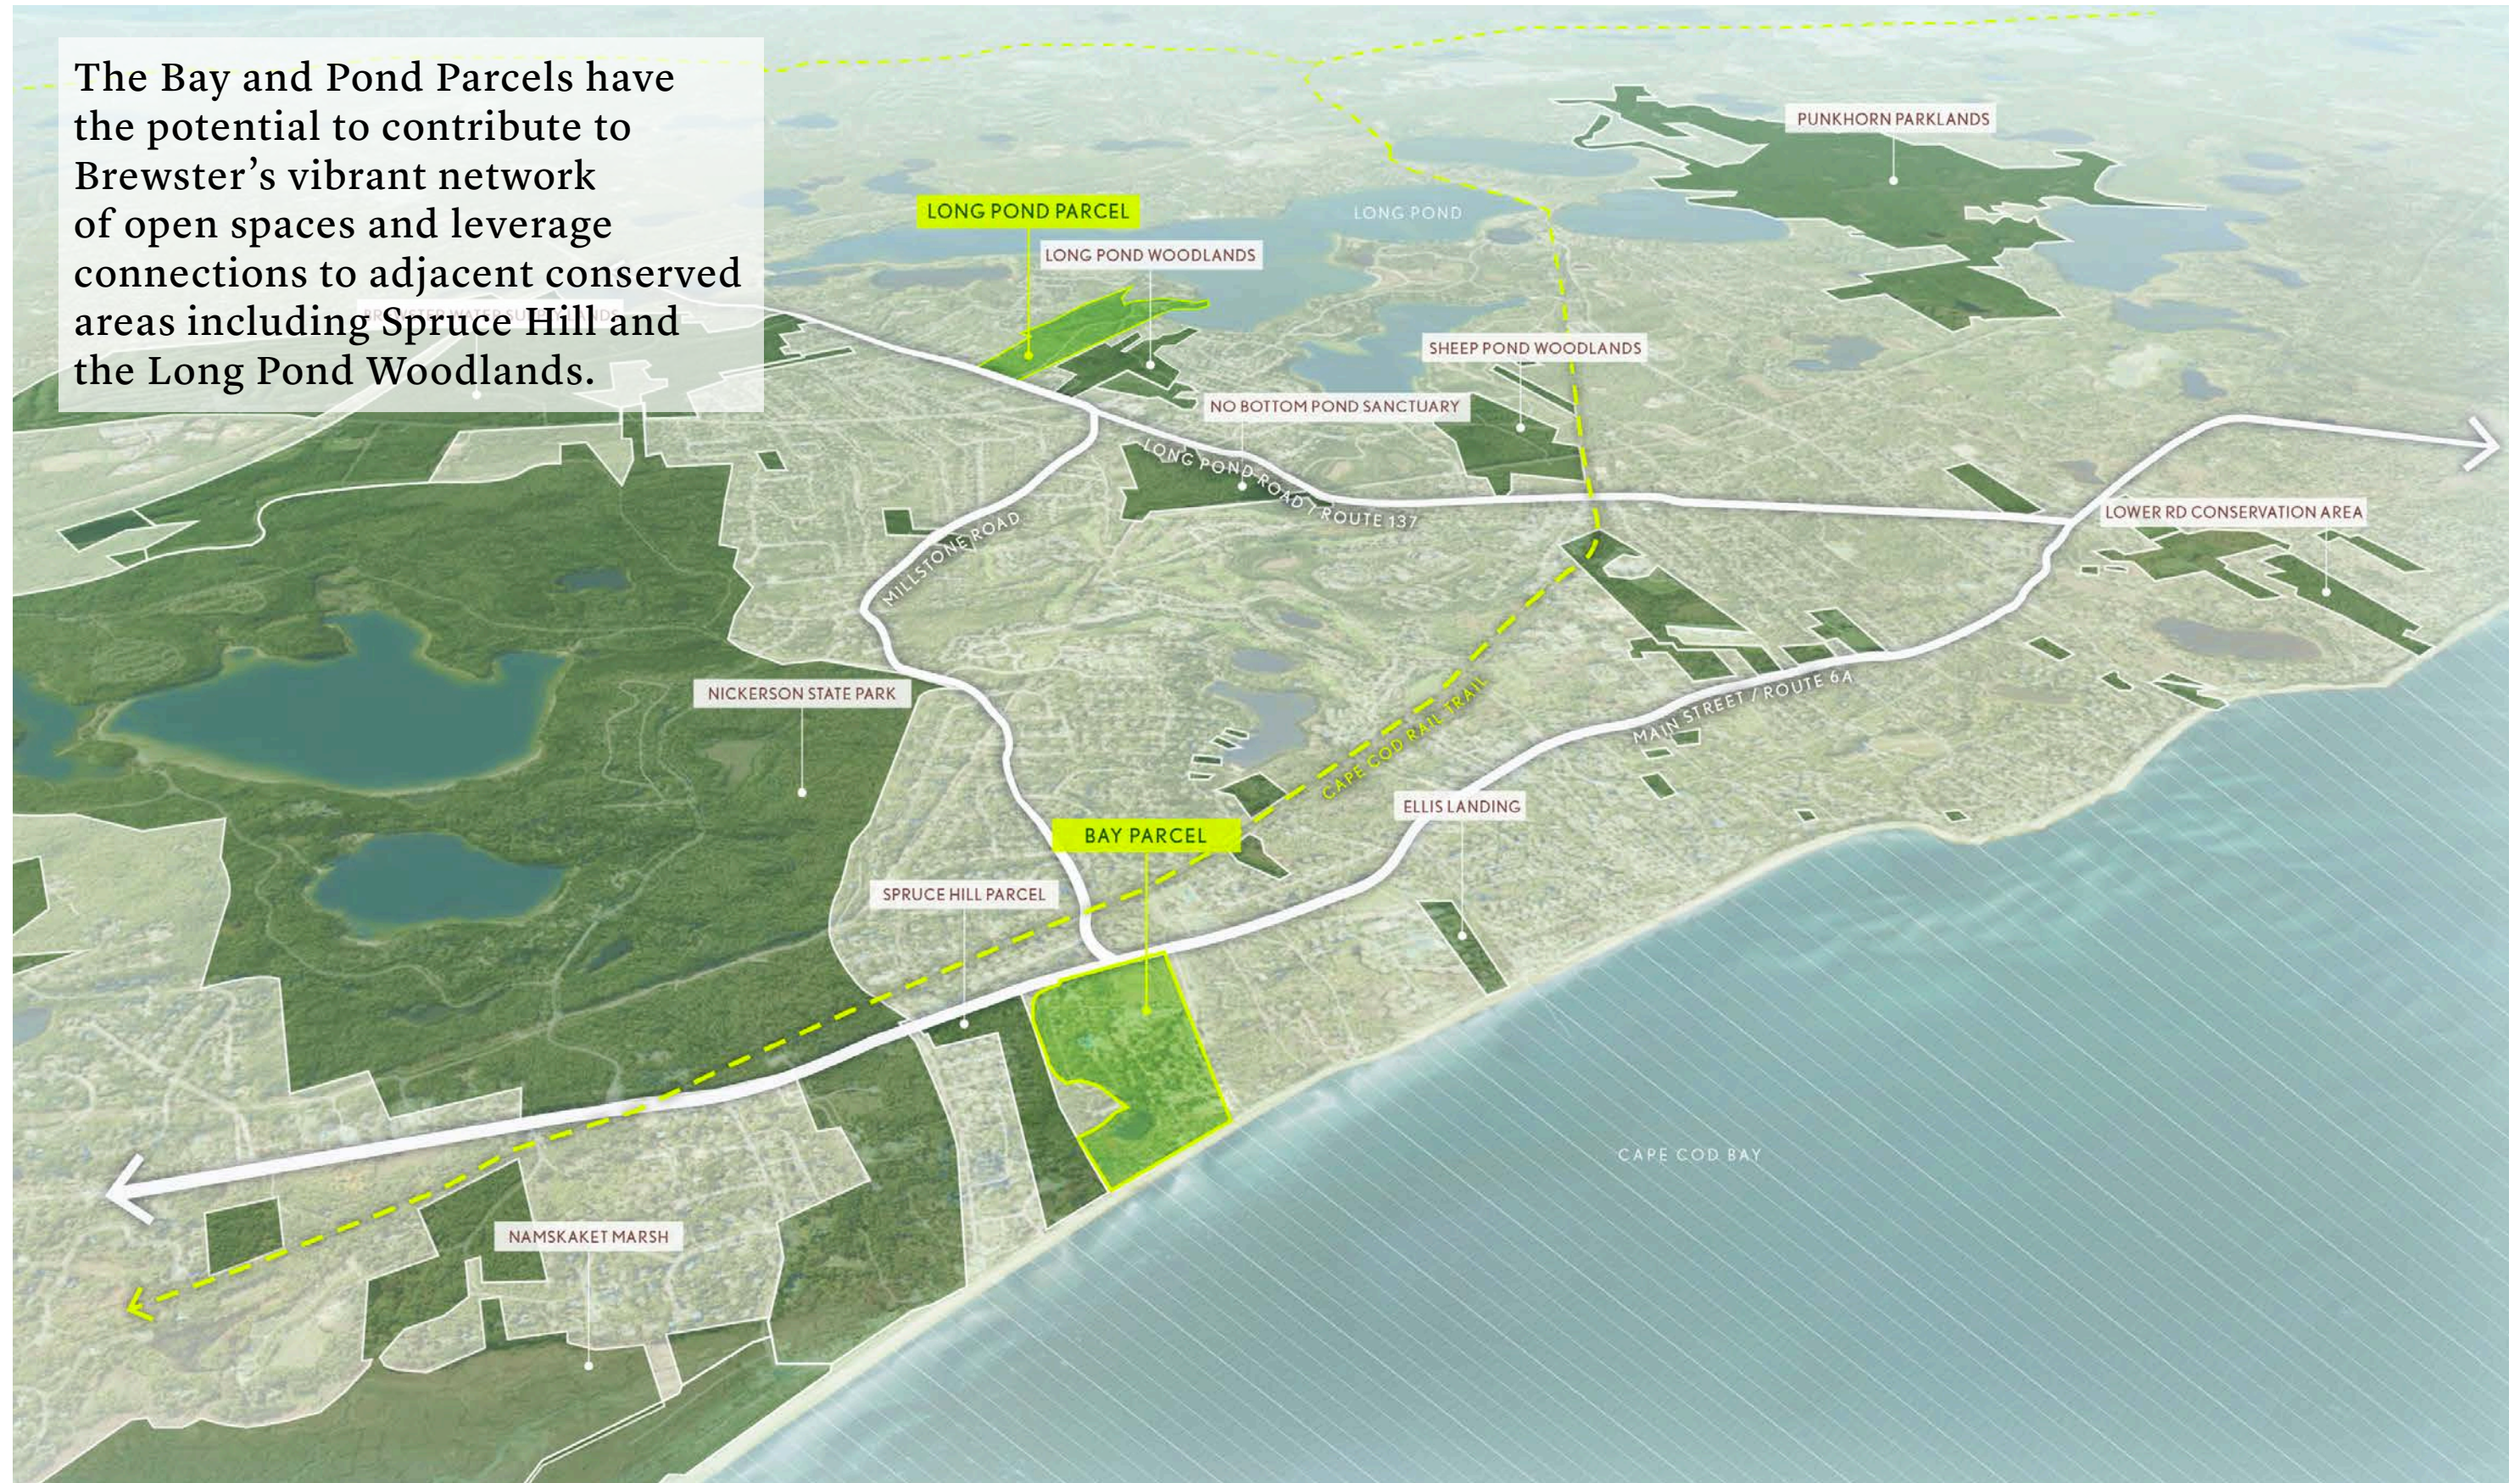
Set Within an Open Space Network

The Bay and Pond Parcels have the potential to contribute to Brewster's vibrant network of open spaces and leverage connections to adjacent conserved areas including Spruce Hill and the Long Pond Woodlands.

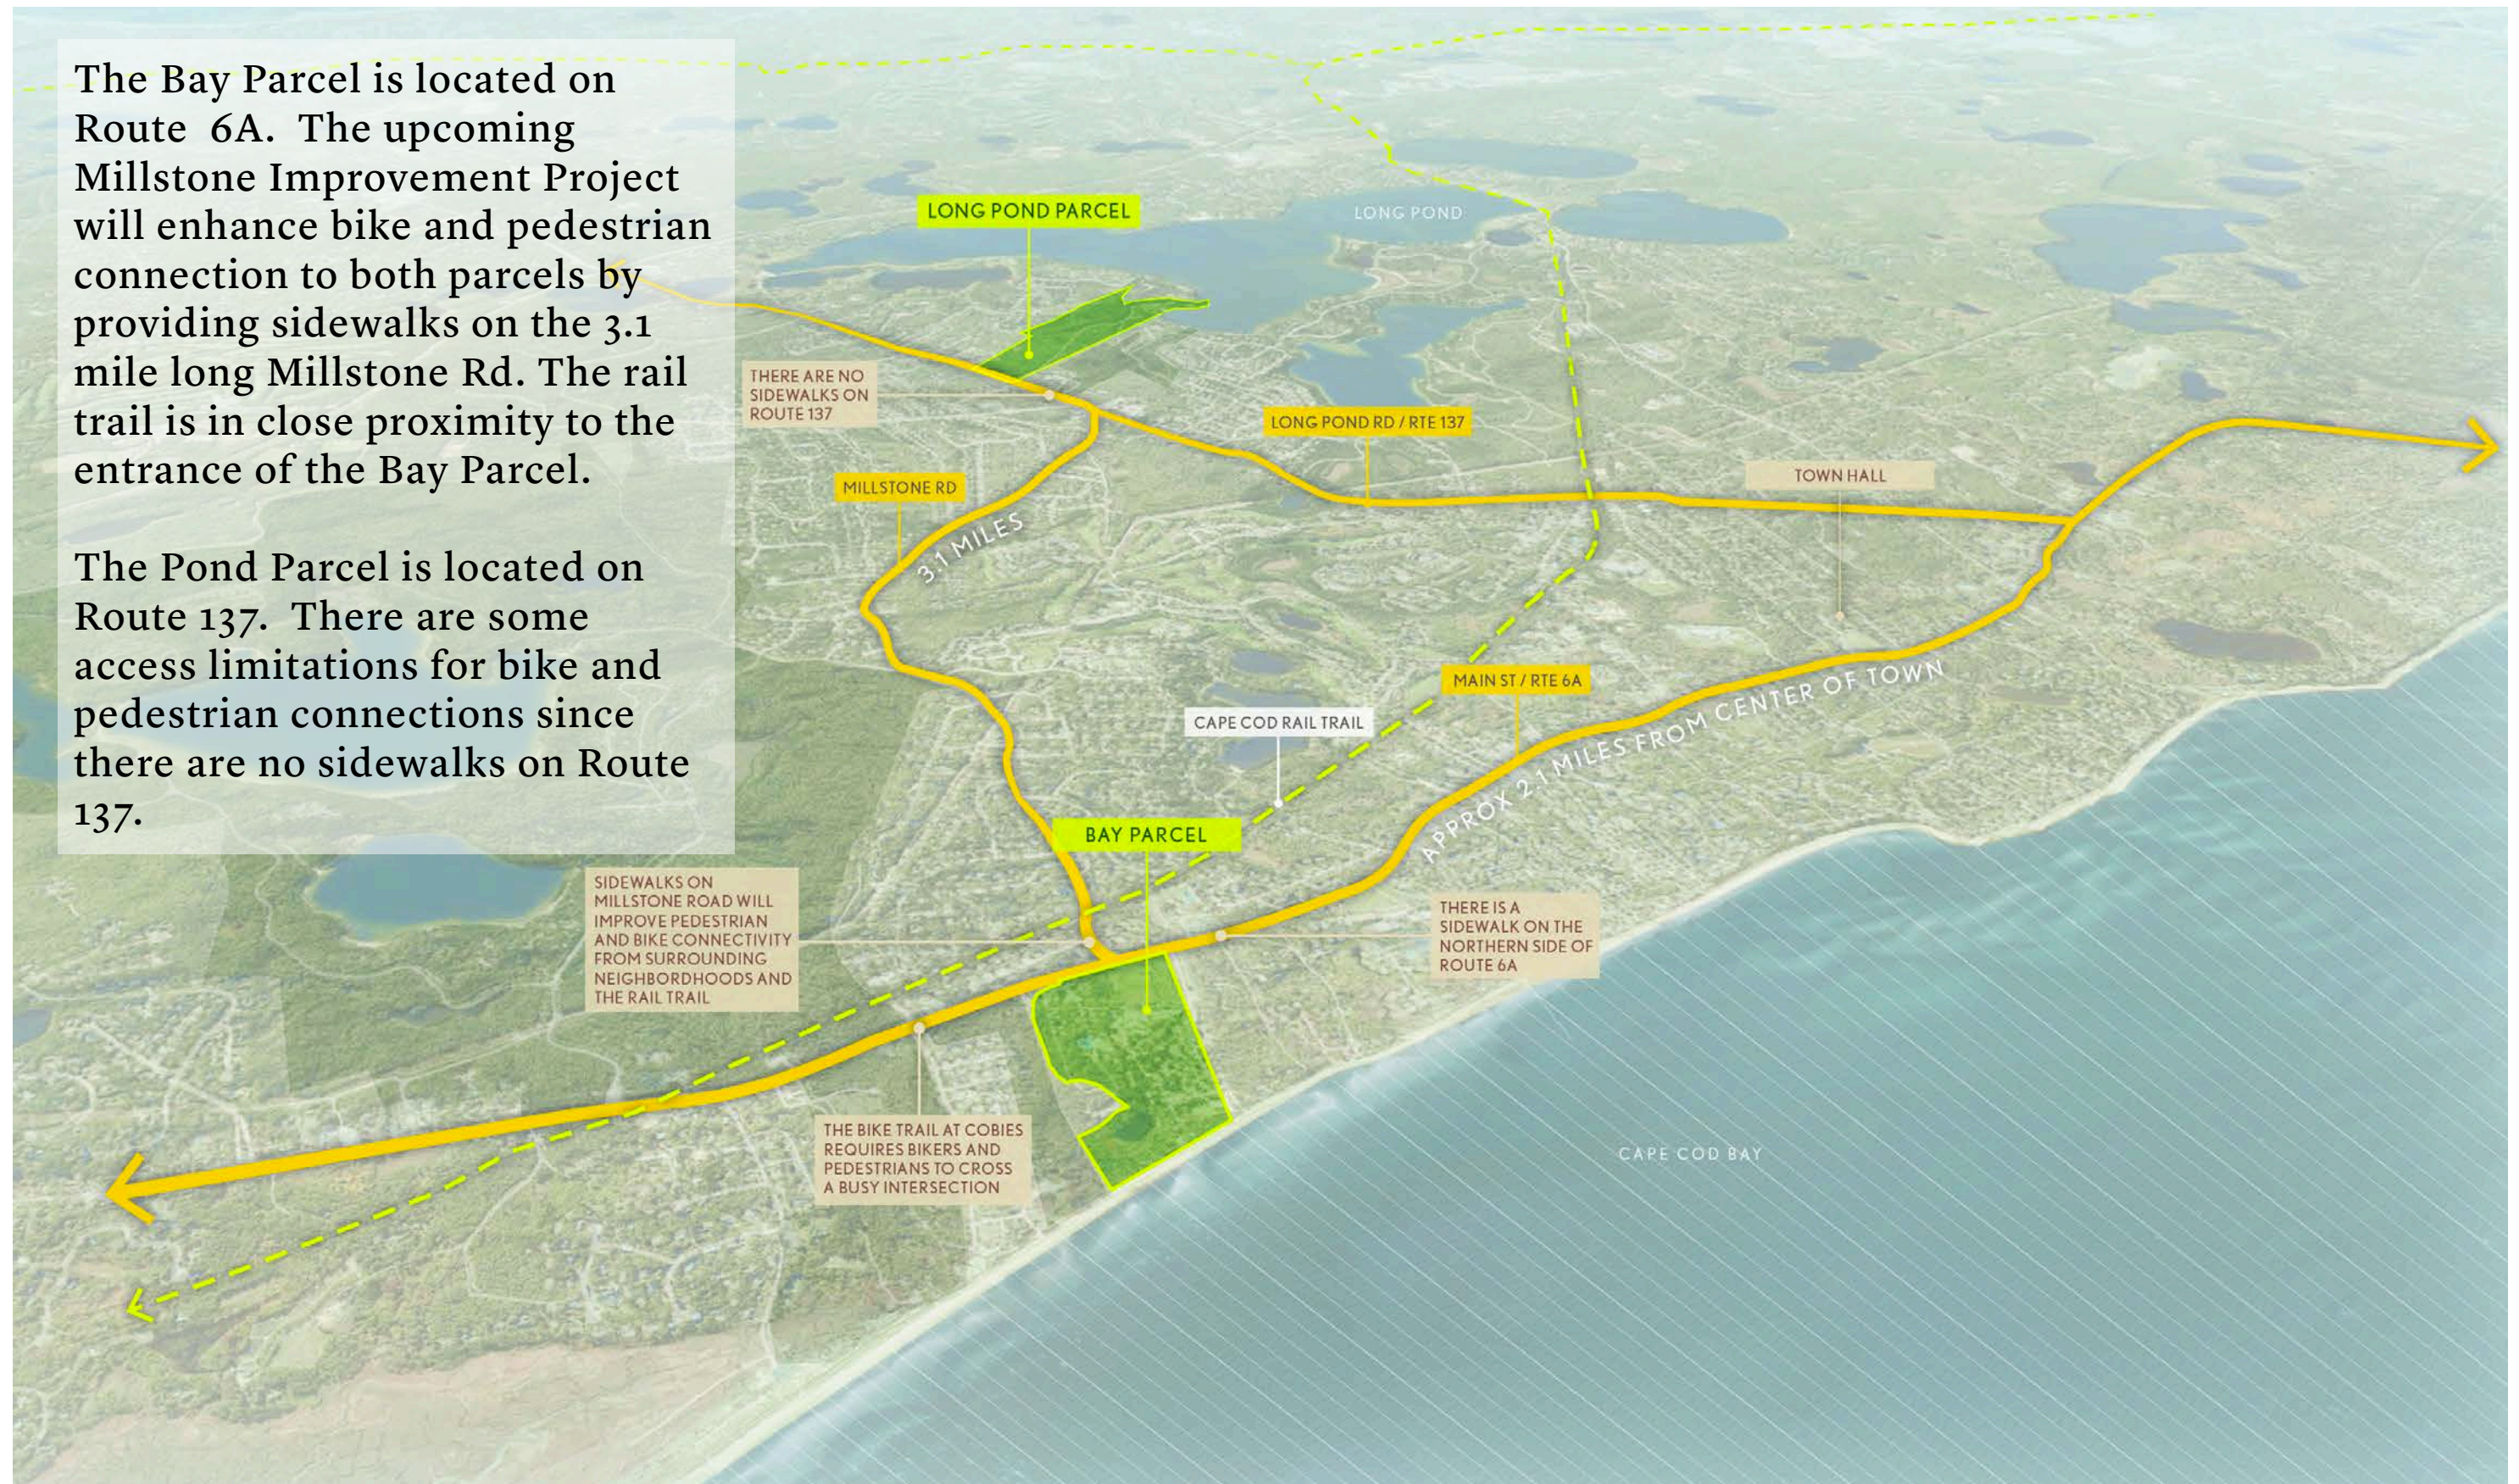
Access

The Bay Parcel is located on Route 6A. The upcoming Millstone Improvement Project will enhance bike and pedestrian connection to both parcels by providing sidewalks on the 3.1 mile long Millstone Rd. The rail trail is in close proximity to the entrance of the Bay Parcel.

The Pond Parcel is located on Route 137. There are some access limitations for bike and pedestrian connections since there are no sidewalks on Route 137.

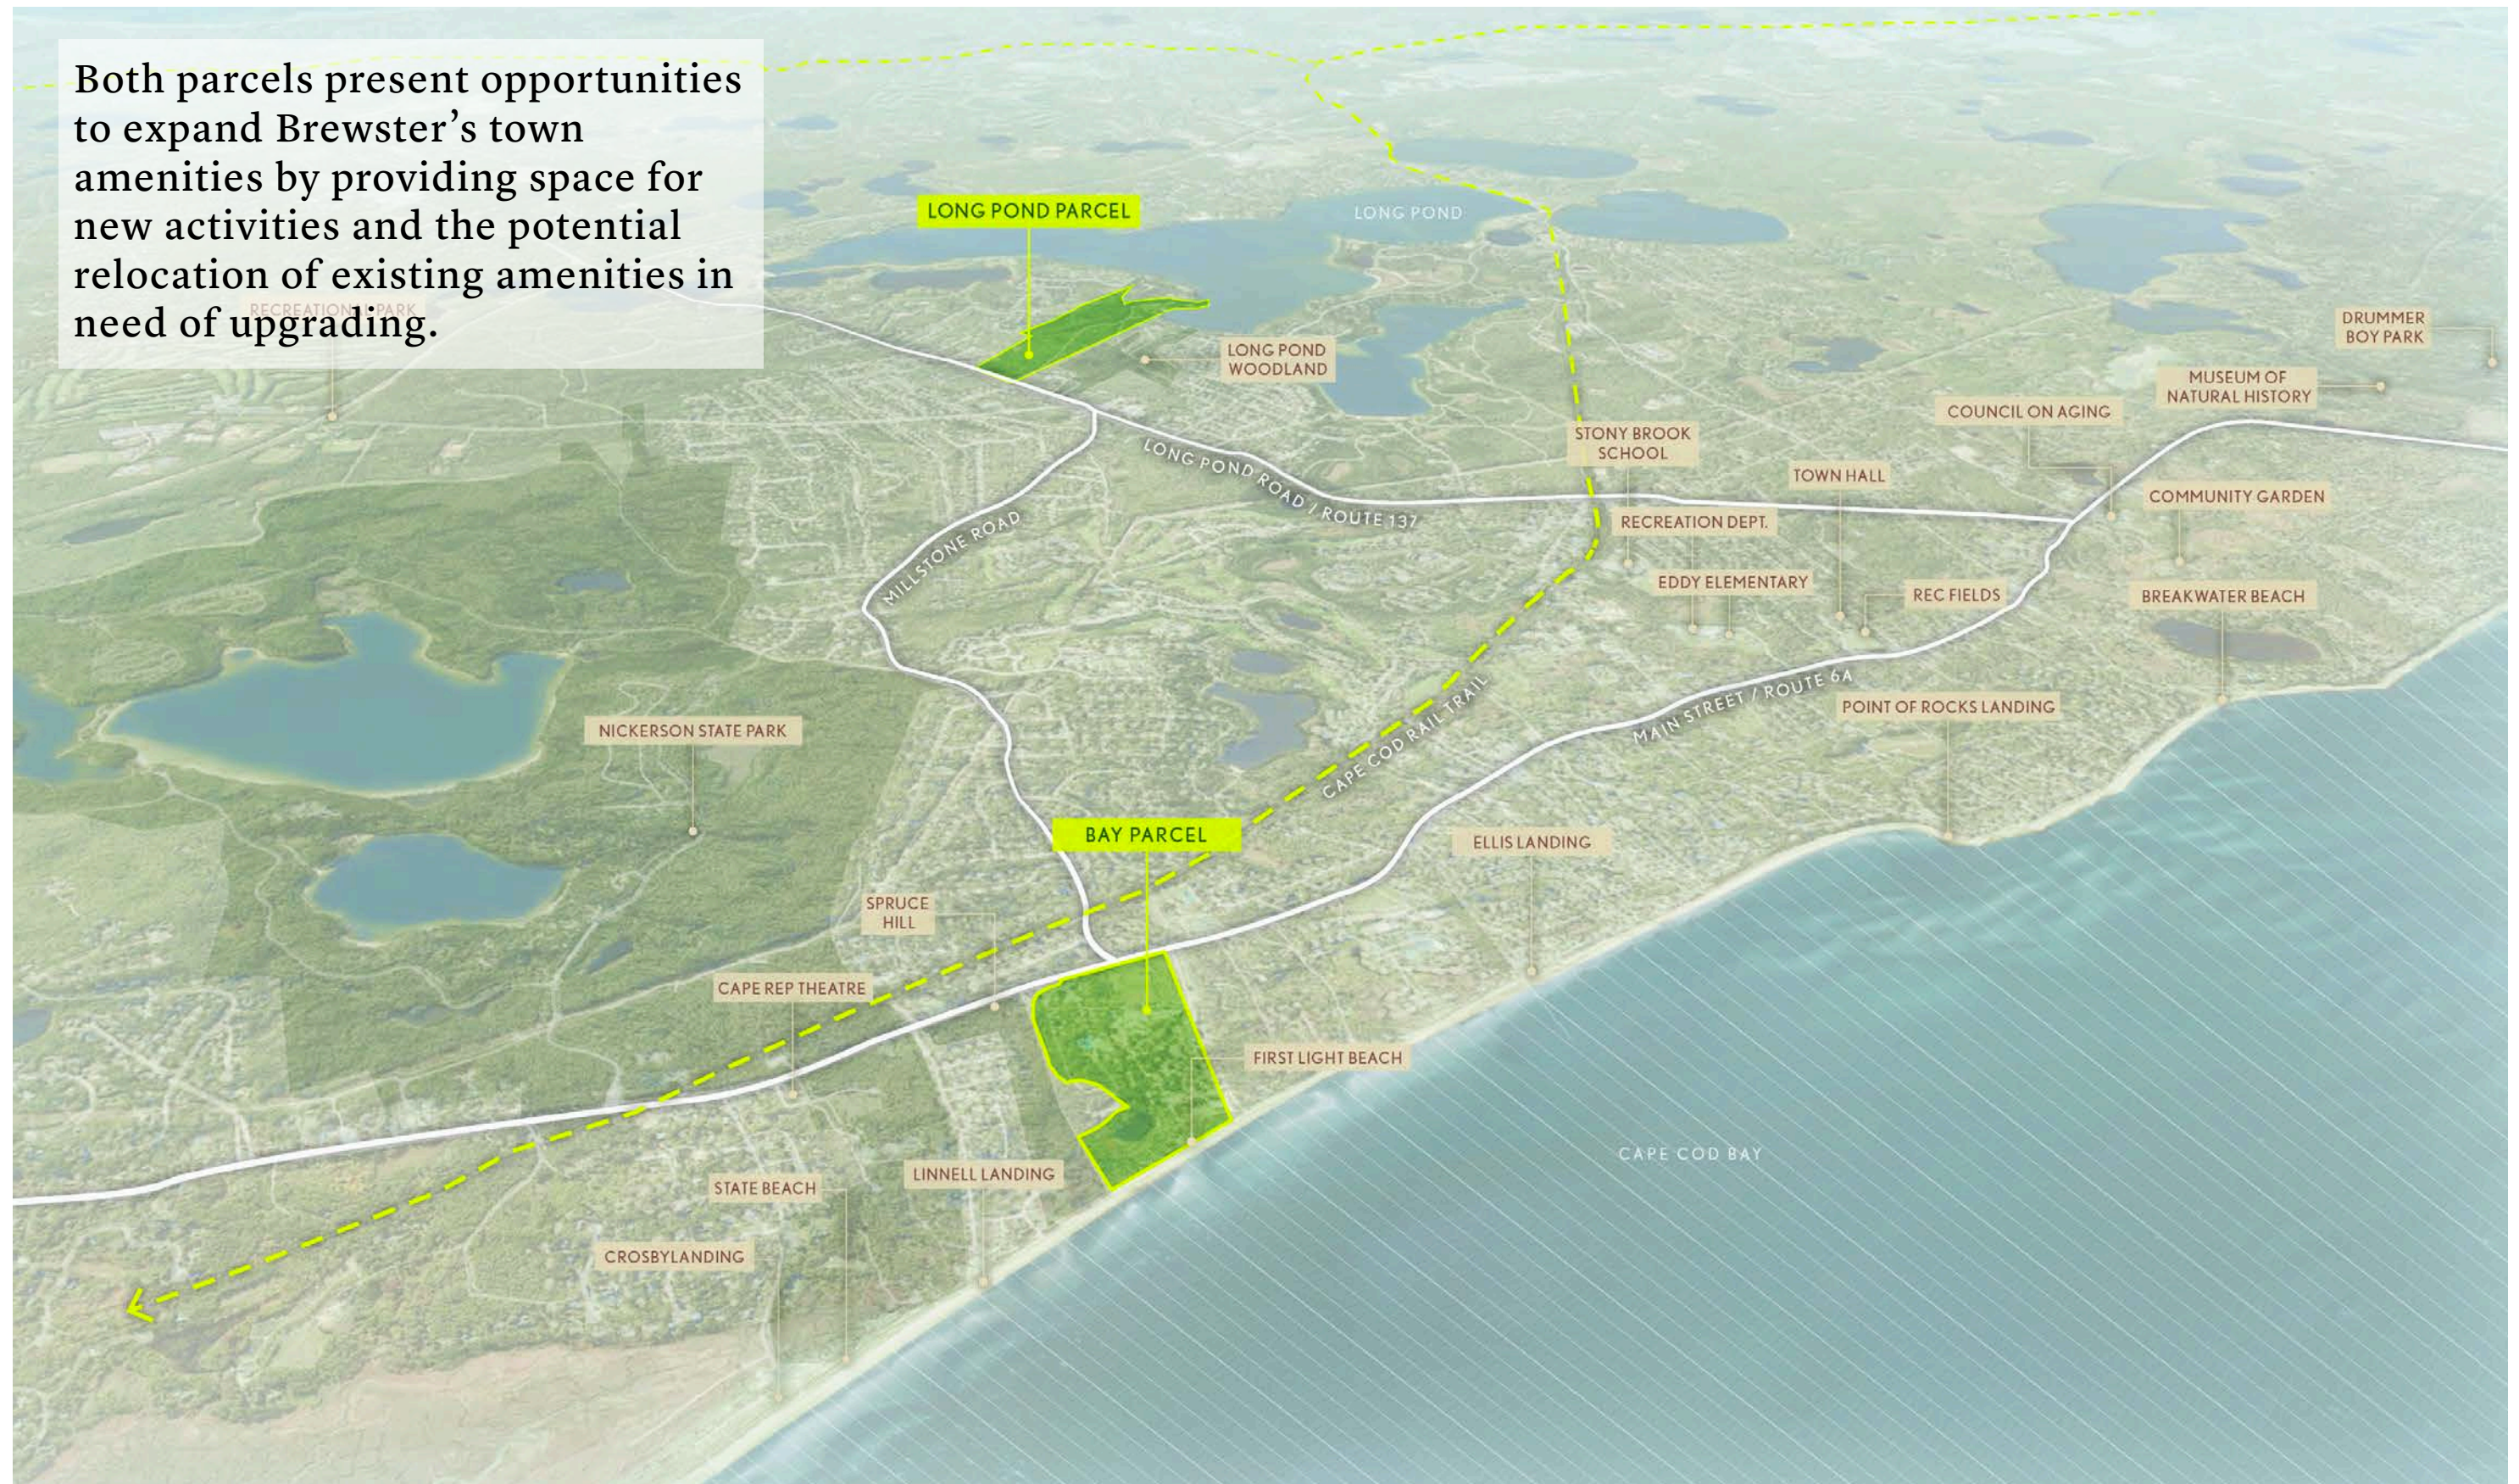
Relationship to Town Amenities

Both parcels present opportunities to expand Brewster's town amenities by providing space for new activities and the potential relocation of existing amenities in need of upgrading.

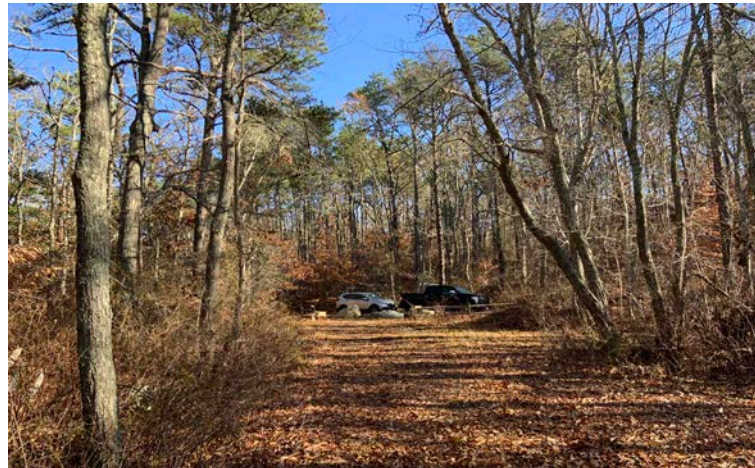
The pond parcel's dramatic topography, descending over 75 feet from a high point at Route 137 to a low point at the pond beach, is characterized by steep slopes on both sides of the road and a distinct upland wooded zone with sunken kettle landforms throughout.

SLOPED ACCESS OFF OF DRIVEWAY

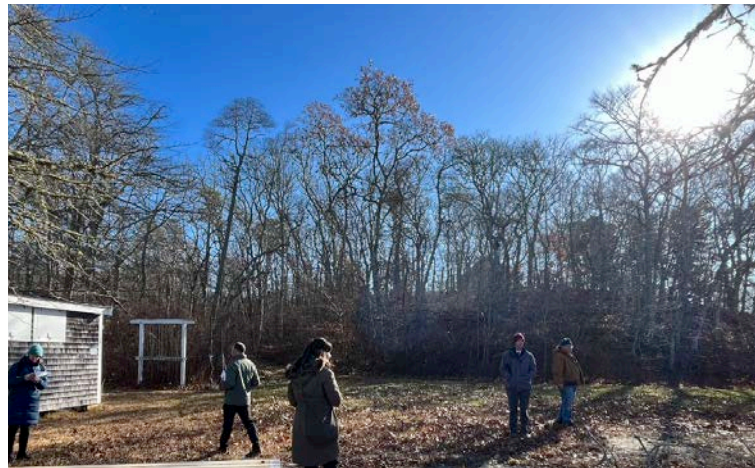
The wetlands and open grassy areas by the pond are surrounded by steep slopes. Steep slopes also characterize the middle portion of the parcel while area under 2% slope is located closer to Route 137.

OPEN AREA BY POND SURROUNDED BY UPLAND FOREST

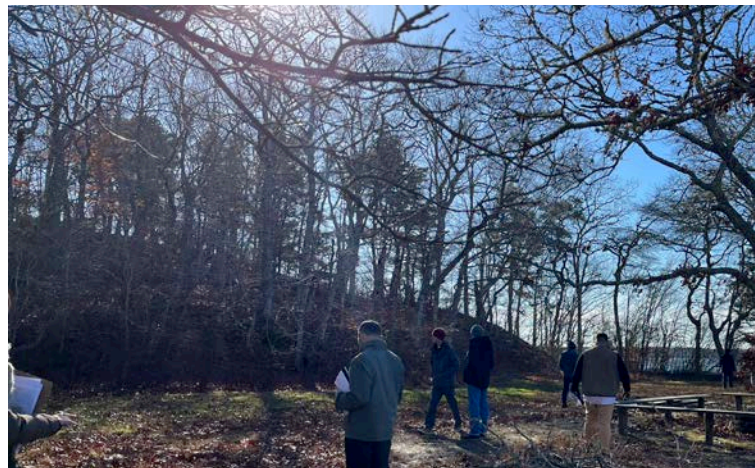
SLOPED TOPOGRAPHY

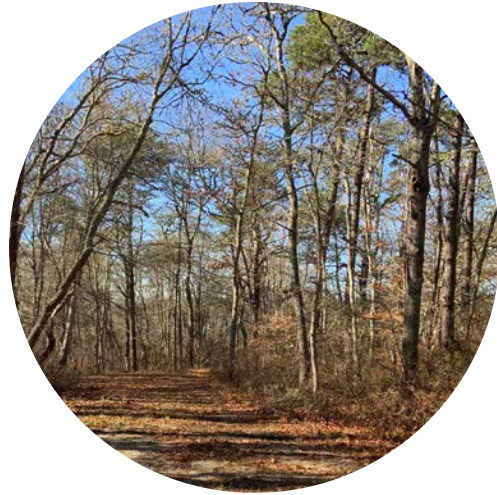
UPLAND WOODLAND

The parcel is composed of upland woodland, wetlands and pond shoreline.

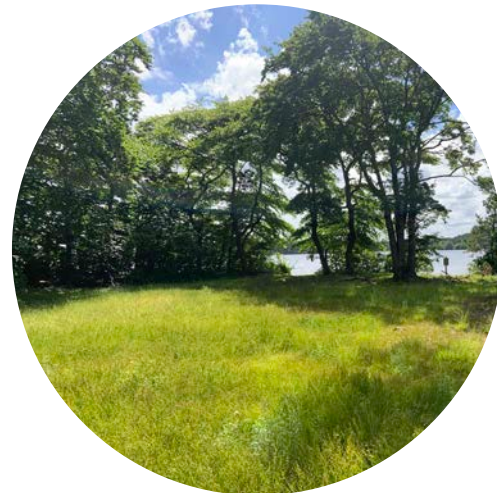
WETLAND AND POND

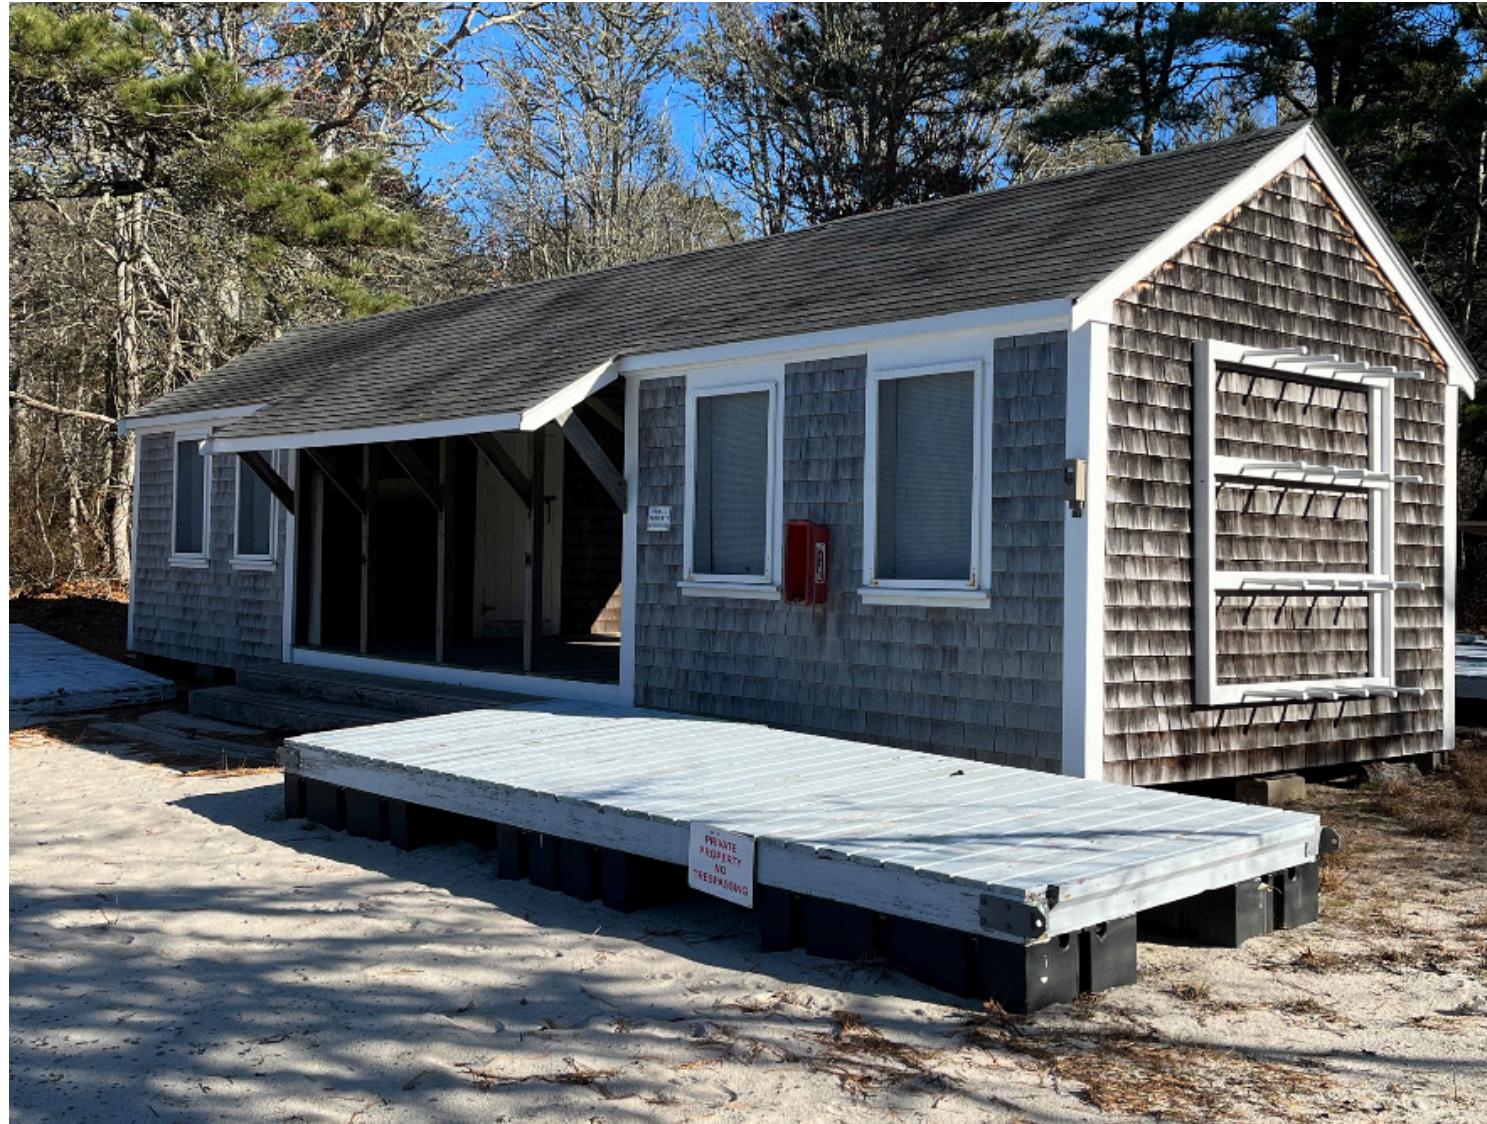
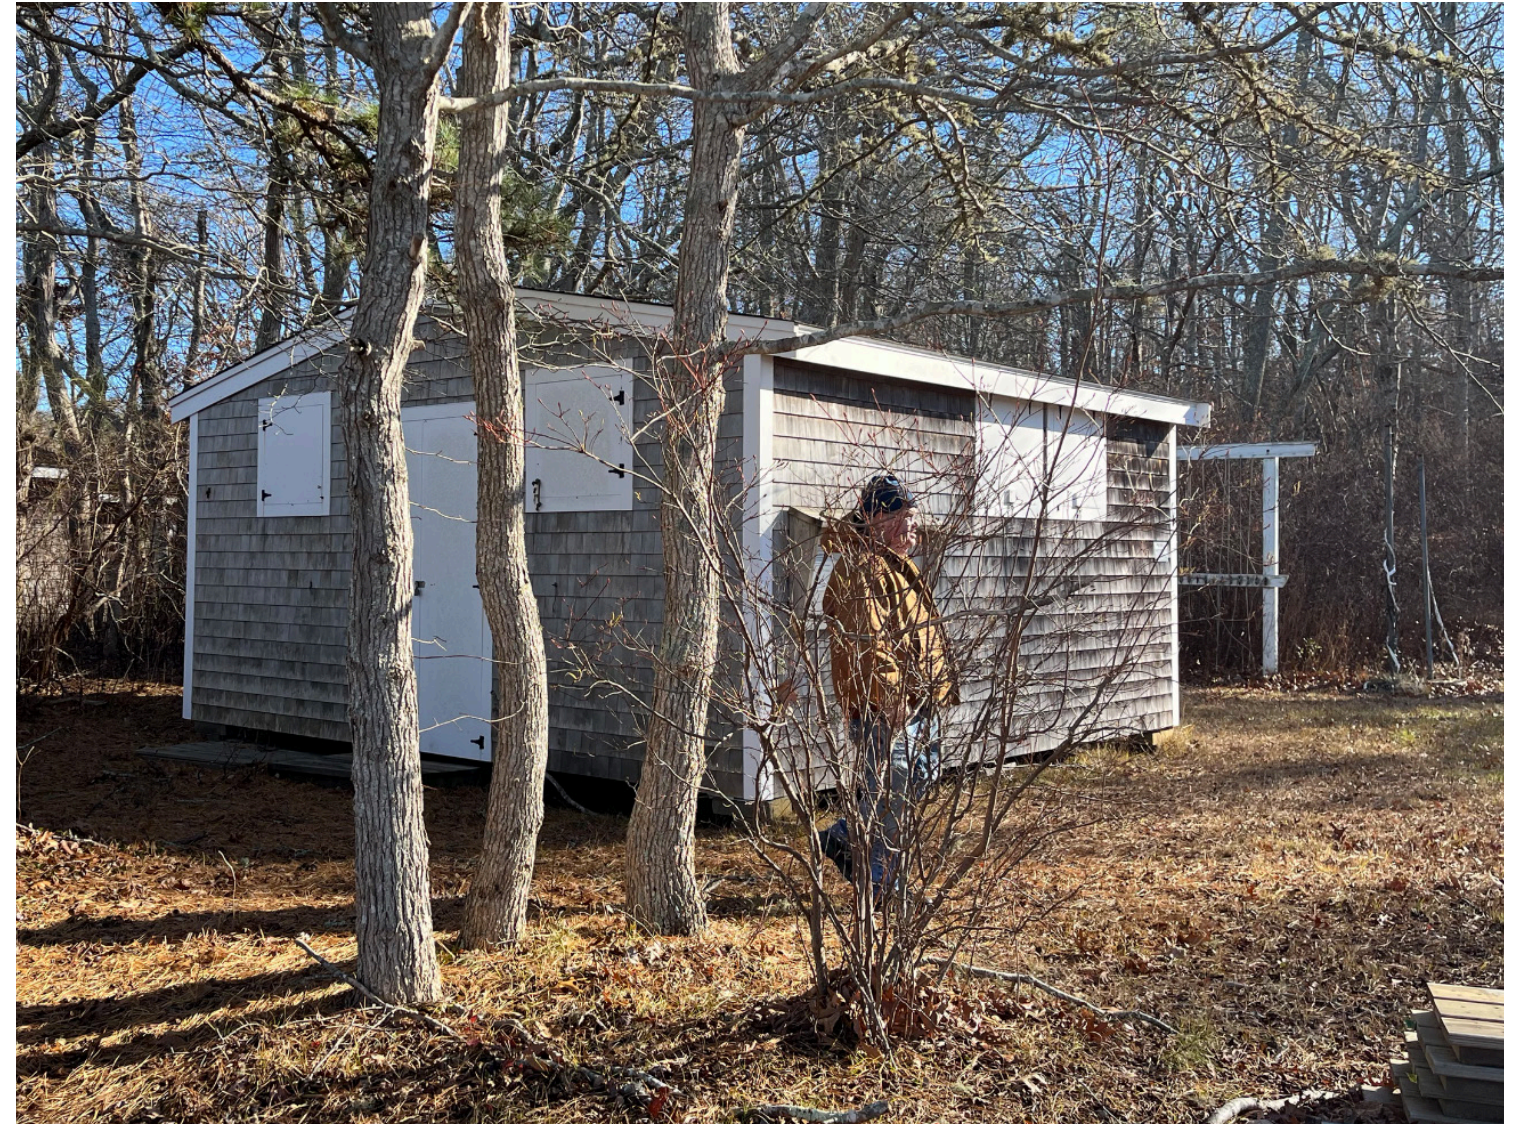
POND PARCEL - BUILDING TYPE

Structures at the Pond Parcel are primarily located near the Pond at a low elevation. Structures are primarily small structures with some storage and amenity buildings. One building is an open air structure. There is an existing dock system that can be re-used if permitted through the Conservation Committee and a new Chapter 91 license is attained.

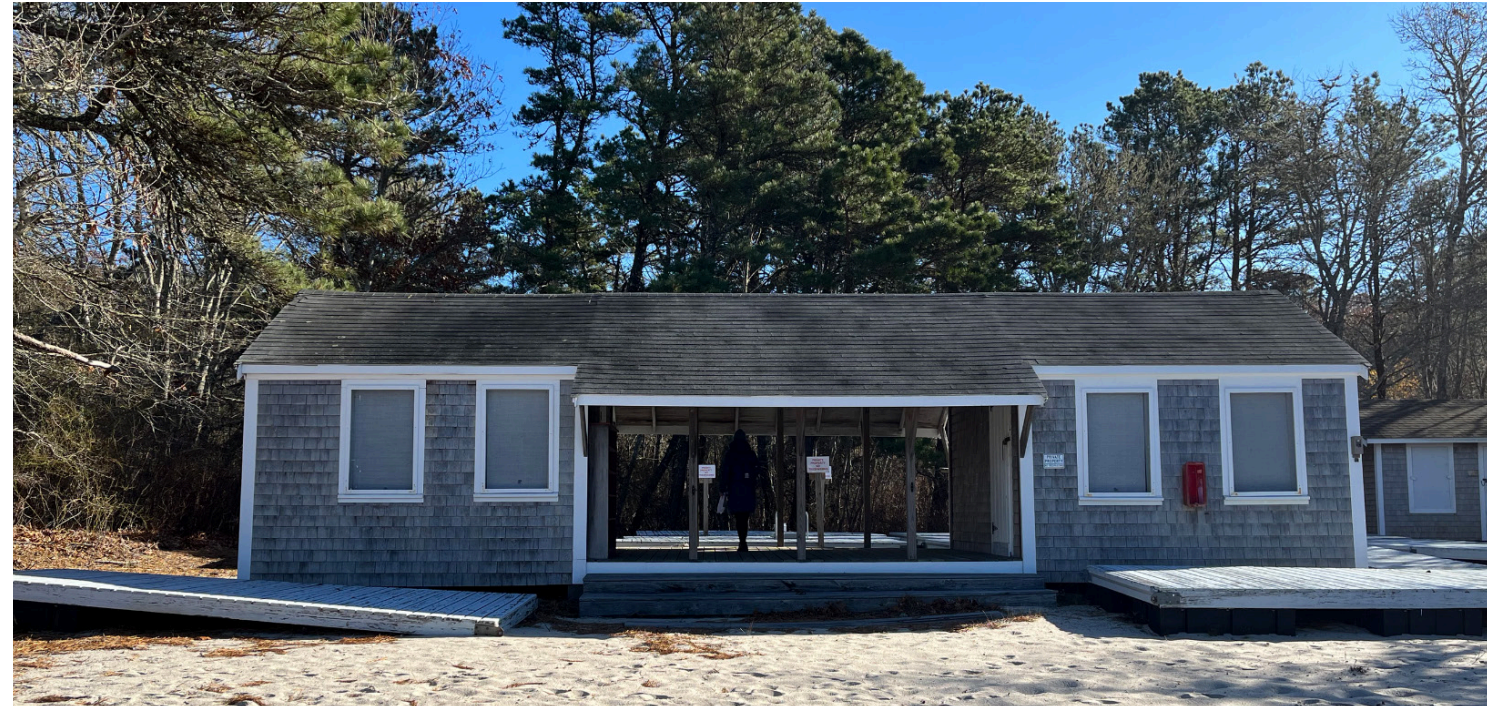
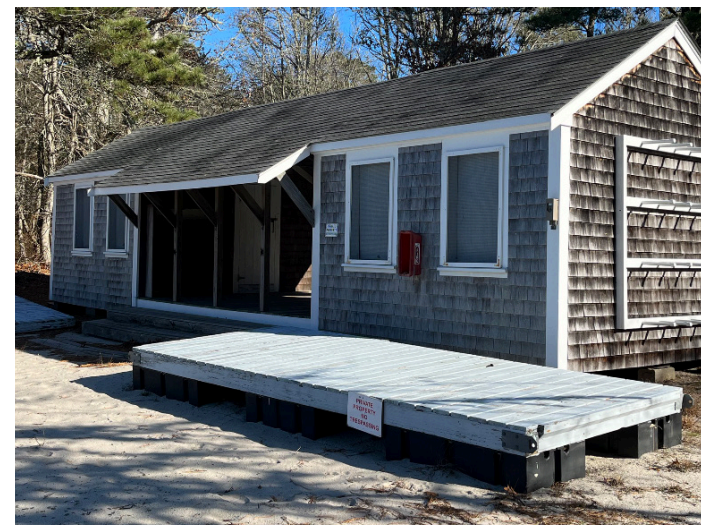
1.1: POND PARCEL BUILDING 1

Building 1	
year built(year renovated):	pre 1970
winterized/conditioned/en-closed:	no
structural type:	wood frame on piers
structural basement:	piers
structural assessment:	TBD
exterior materiality:	wood shingles
interior materiality:	minimum
number of bathrooms:	0
number of rooms:	1
kitchen yes/no:	no
basement yes/no:	no
attic yes/no:	no
roof type/condition:	asphalt shingles
prior uses:	storage
moved/original location:	moved

Height:	12 ft*
Footprint:	450 sqft*
Gross Area:	450 sqft*
Number of Stories:	1

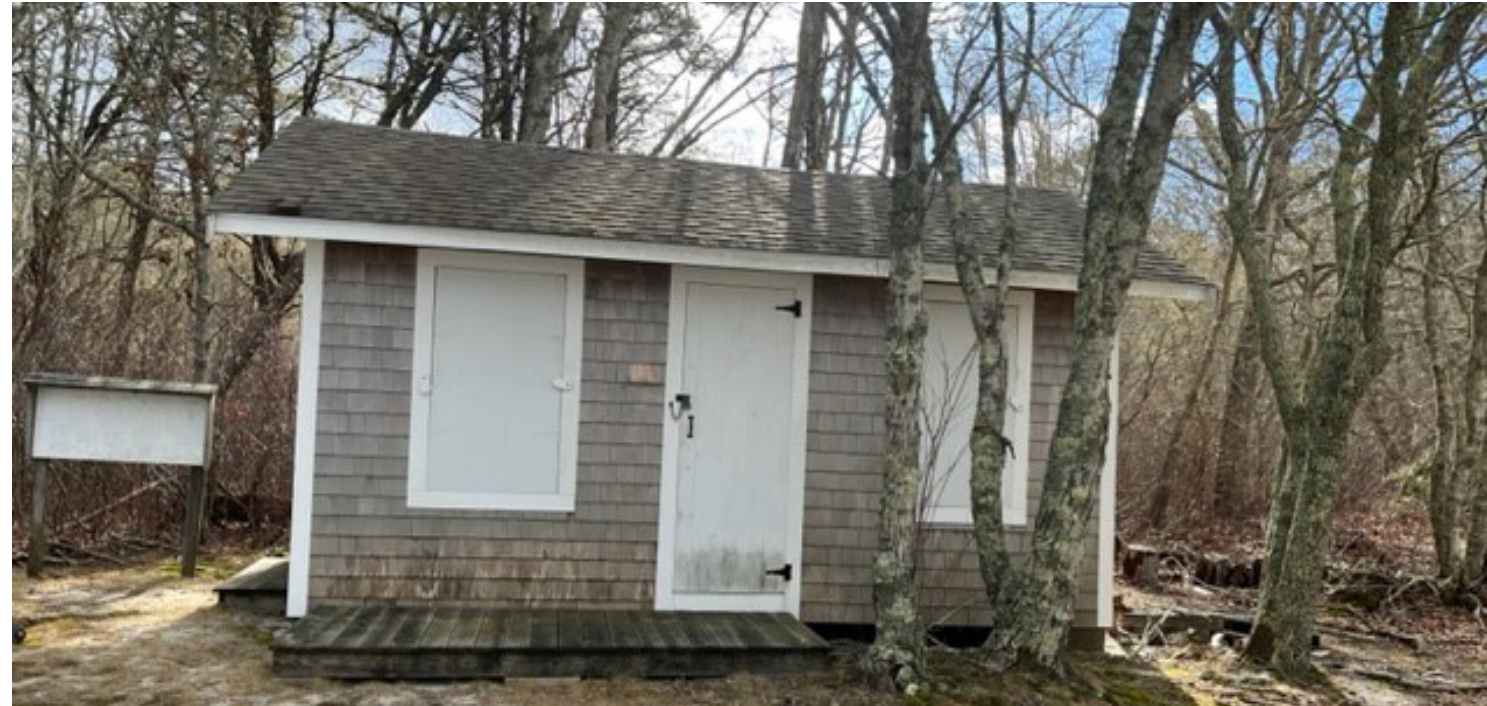
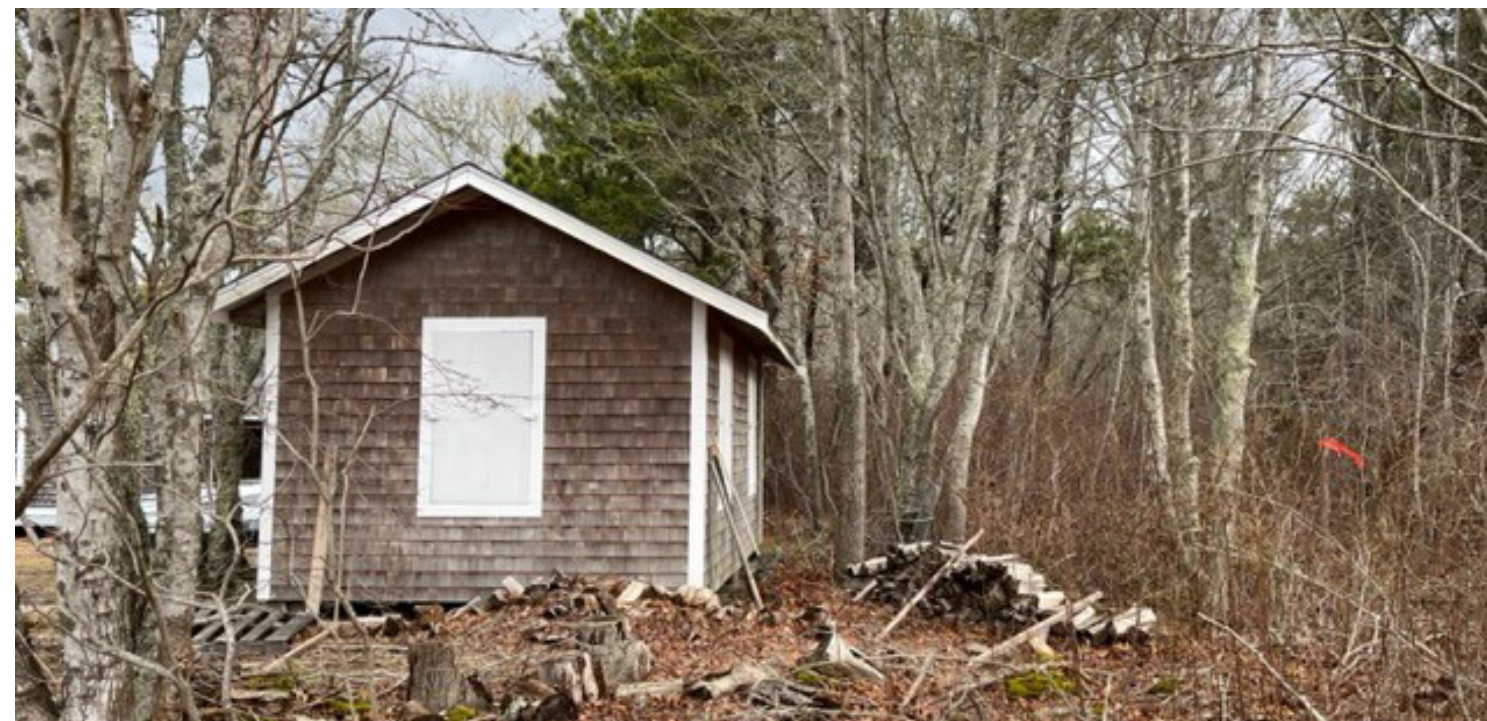
1.1: POND PARCEL BUILDING 2

Building 2	
year built(year renovated):	pre 1970
winterized/conditioned/en-closed:	no
structural type:	wood frame on piers
structural assessment:	TBD
exterior materiality:	wood shingles
interior materiality:	minimum
number of bathrooms:	0
number of rooms:	1
kitchen yes/no:	no
basement yes/no:	no
attic yes/no:	no
roof type/condition:	asphalt shingles
prior uses:	storage
moved/original location:	moved

Height:	12 ft*
Footprint:	230 sqft*
Gross Area:	230 sqft*
Number of Stories:	1
