Town of Brewster Sea Camps Pond Parcel Discovery Analysis

March 29, 2023

REED HILDERBRAND

Building Analysis

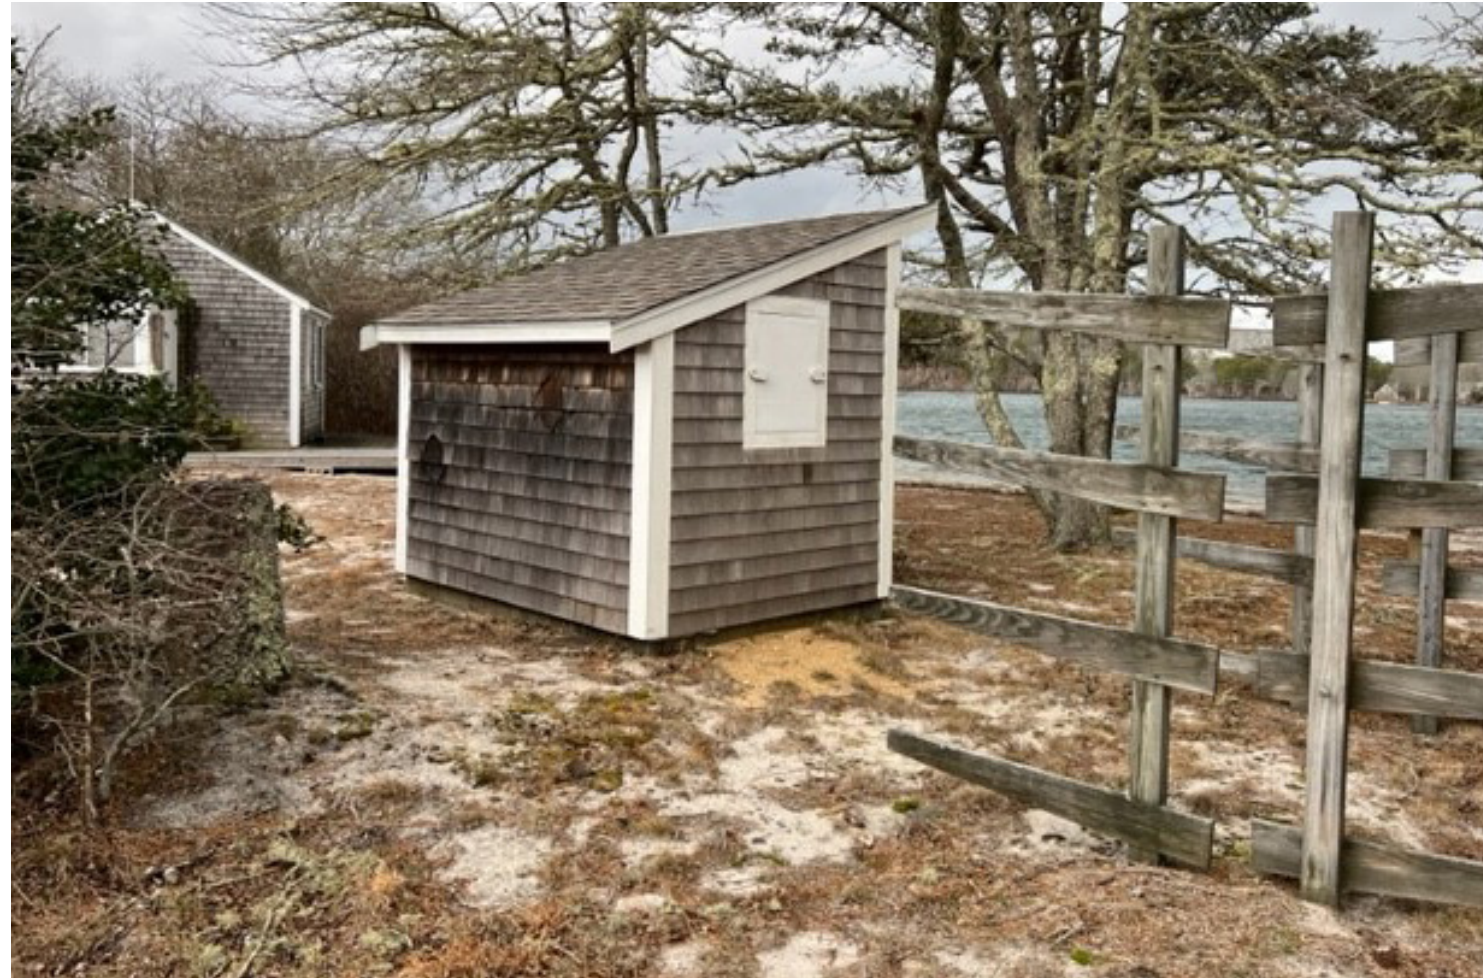
1.1: POND PARCEL BUILDING 3

Building 3	
year built(year renovated):	pre 1970
winterized/conditioned/en-closed:	no
structural type:	wood frame on piers
structural assessment:	TBD
exterior materiality:	wood shingles
interior materiality:	minimum
number of bathrooms:	0
number of rooms:	1
kitchen yes/no:	no
basement yes/no:	no
attic yes/no:	no
roof type/condition:	asphalt shingles
prior uses:	gas & tool storage
moved/original location:	moved

Height:	12 ft*
Footprint:	55 sqft*
Gross Area:	55 sqft*
Number of Stories:	1

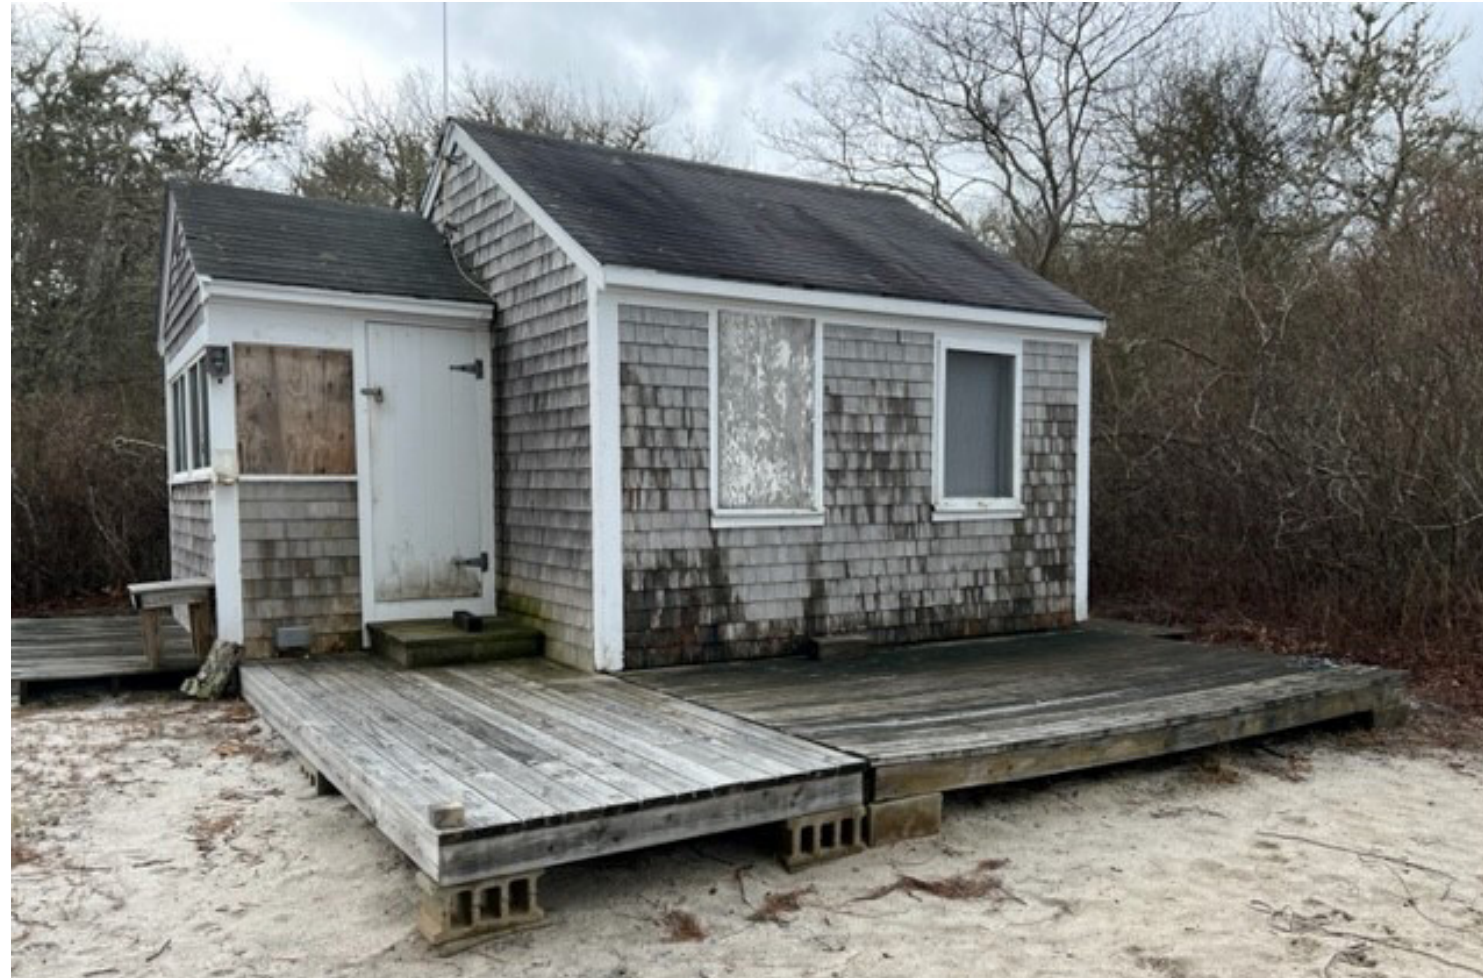
1.1: POND PARCEL BUILDING 4

Building 4	
year built(year renovated):	pre 1970
winterized/conditioned/en-closed:	no
structural type:	wood frame on piers
structural assessment:	TBD
exterior materiality:	wood shingles
interior materiality:	minimum
number of bathrooms:	0
number of rooms:	1
kitchen yes/no:	no
basement yes/no:	no
attic yes/no:	no
roof type/condition:	asphalt shingles
prior uses:	office, caretaker
moved/original location:	moved

Height:	12 ft*
Footprint:	330 sqft*
Gross Area:	330 sqft*
Number of Stories:	1

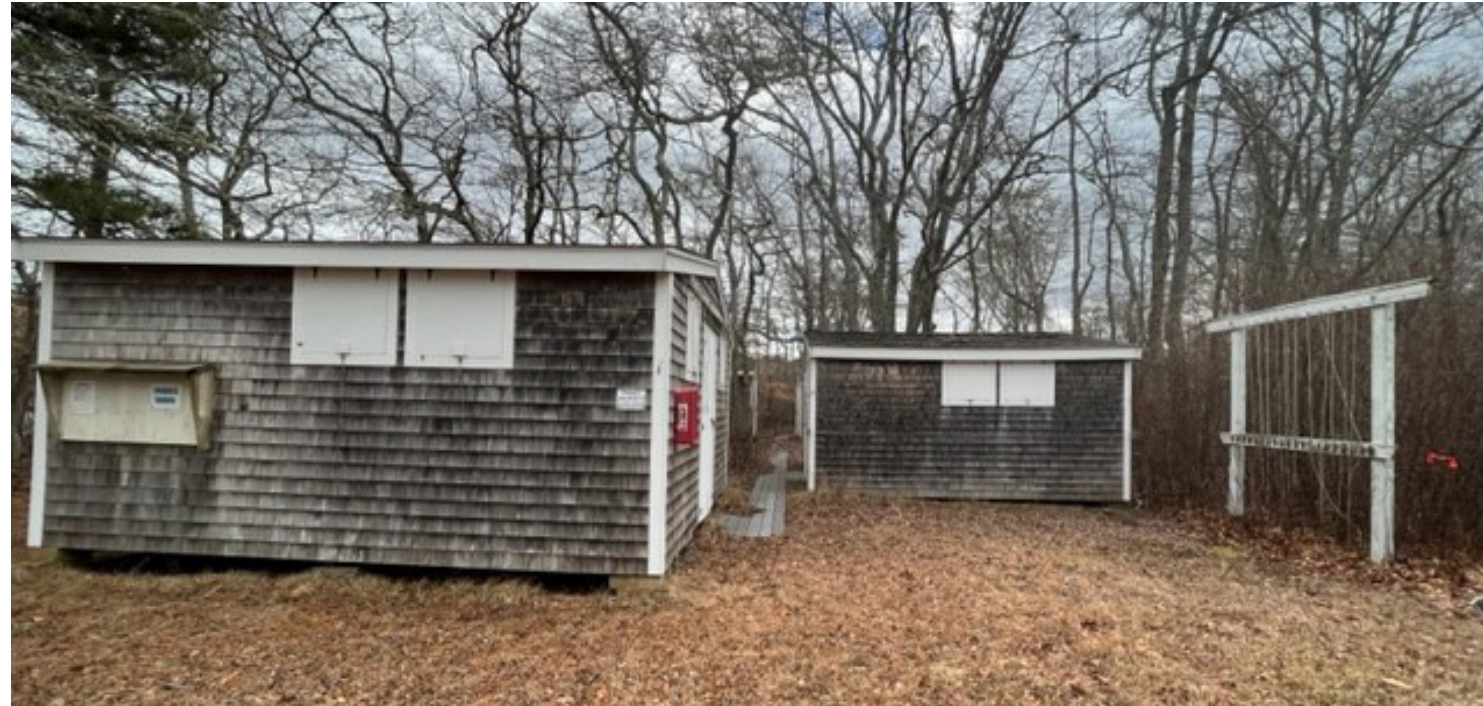
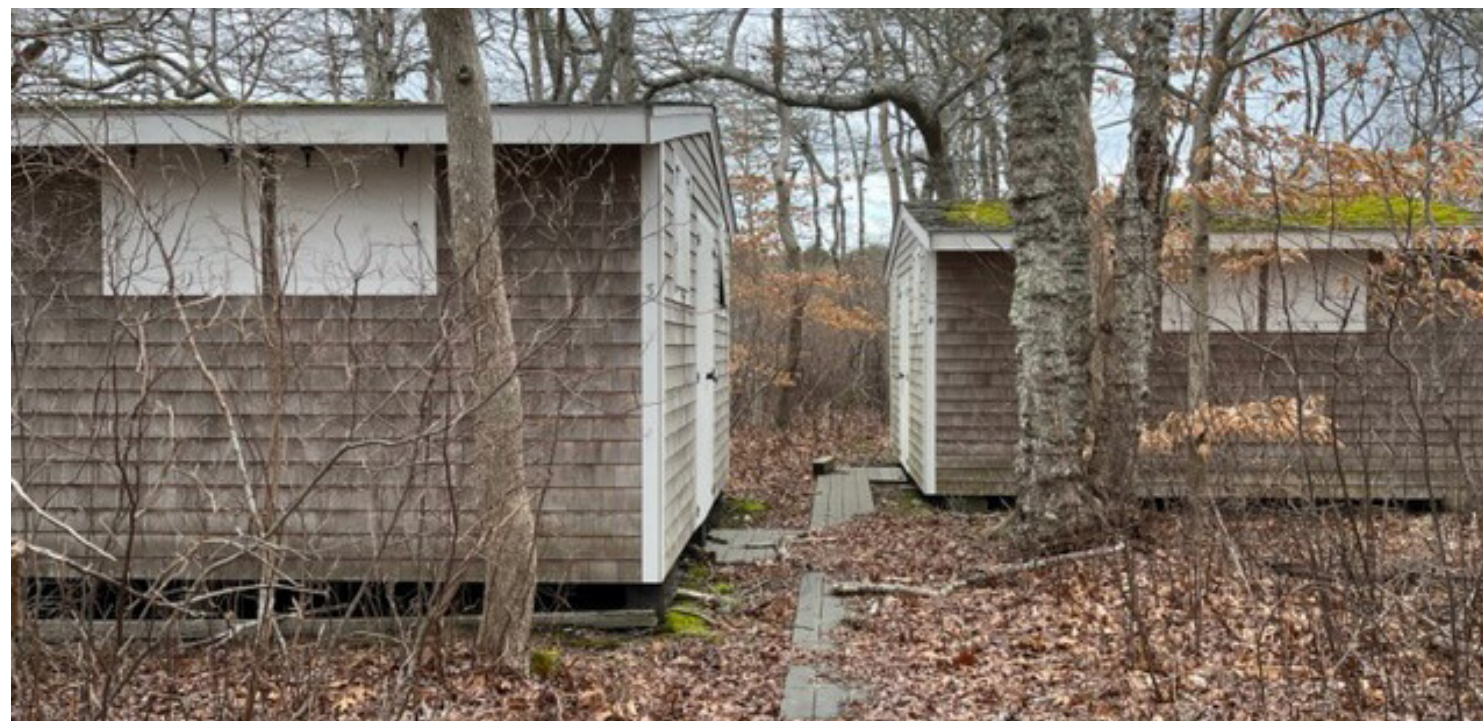
1.2: POND PARCEL BUILDING 5-8

Buildings 5-8	
year built(year renovated):	pre 1970
winterized/conditioned/en-closed:	no
structural type:	wood frame on piers
structural assessment:	TBD
exterior materiality:	wood shingles
interior materiality:	minimum
number of bathrooms:	0
number of rooms:	1
kitchen yes/no:	no
basement yes/no:	no
attic yes/no:	no
roof type/condition:	asphalt shingles
prior uses:	storage
moved/original location:	original location

Height:	12 ft
Footprint:	330 sqft*
Gross Area:	330 sqft*
Number of Stories:	1

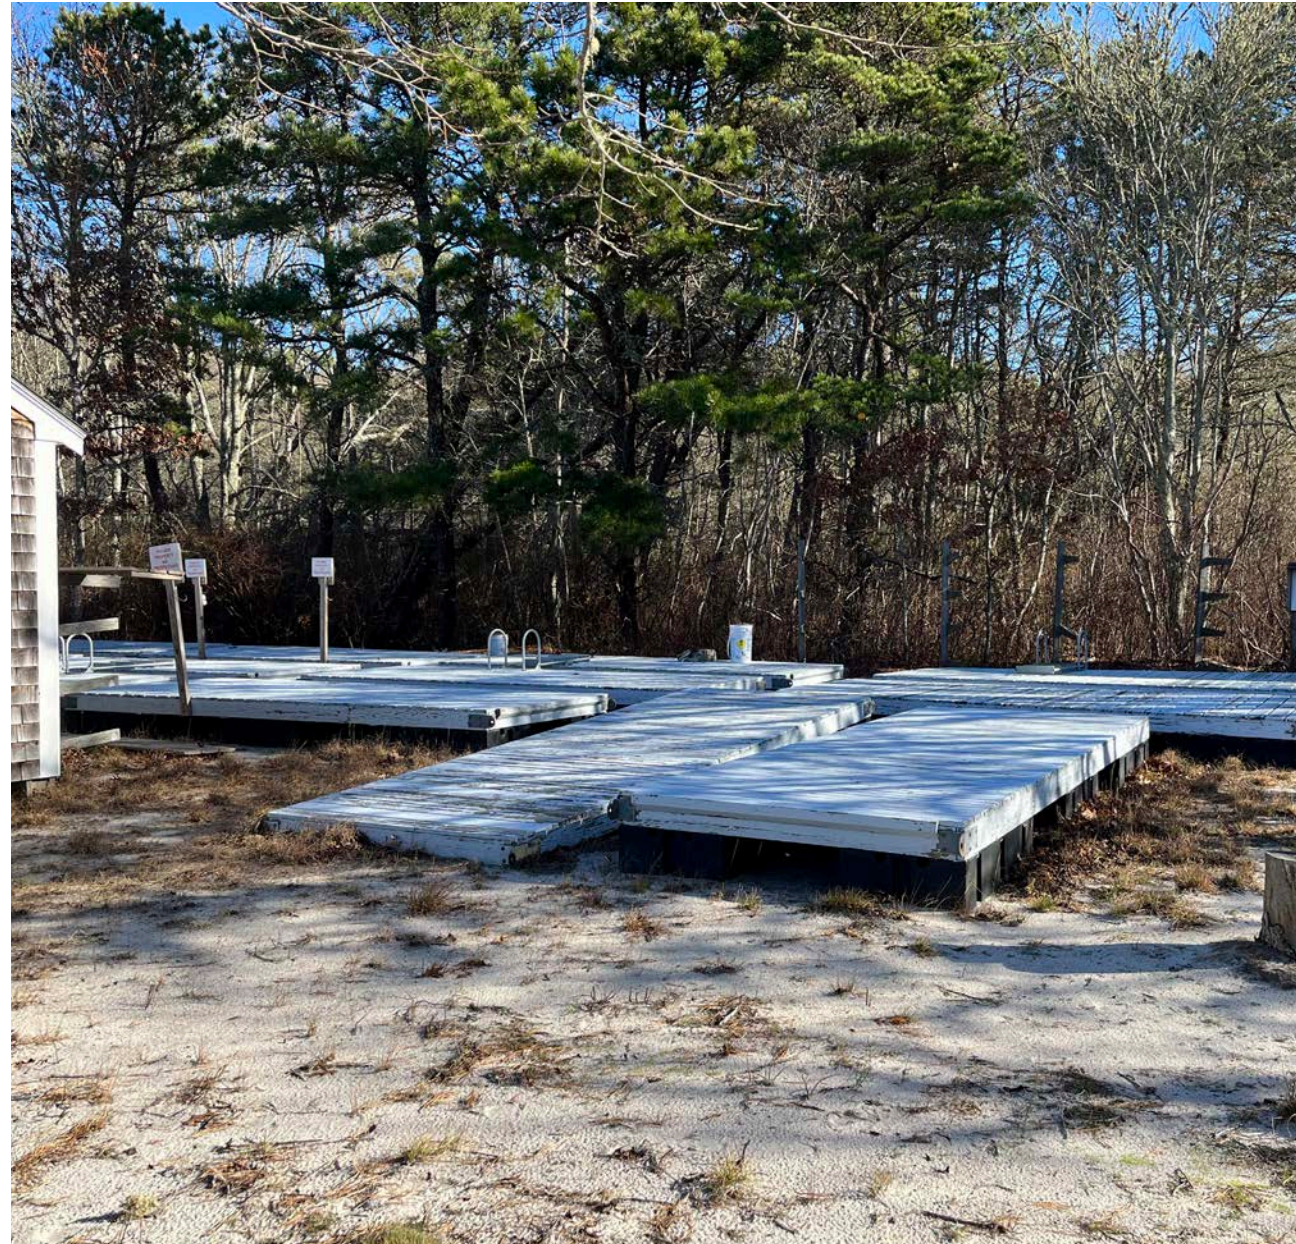
1.2: POND PARCEL SWIM DOCK

Swim Dock	
year built(year renovated):	pre 1970
winterized/conditioned/en-closed:	NA
structural type:	wood decking
structural assessment:	TBD
exterior materiality:	wood
interior materiality:	NA
number of bathrooms:	NA
number of rooms:	NA
kitchen yes/no:	NA
basement yes/no:	NA
attic yes/no:	NA
roof type/condition:	NA
prior uses:	swim dock
moved/original location:	moved and currently out of use
